**ASBESTOS CONTAINING MATERIALS
SURVEY REPORT**

**BUILDING 607
CYRIL GOLDING LIBRARY
Gladstone Marina Campus
Bryan Jordan Drive, Gladstone Marina, Queensland**

Report Number 622.10968.00000/0020-R01-Bld 607-ASR

28 September 2017

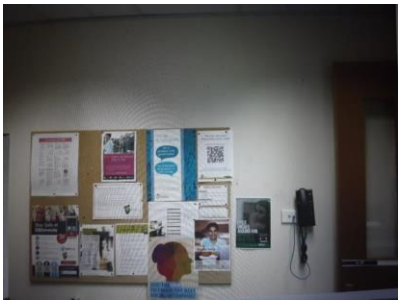
Ground Floor G.07	WALL SHEETING - WESTERN ELEVATION , Fibrous Cement	10m ²	NAD
3-749

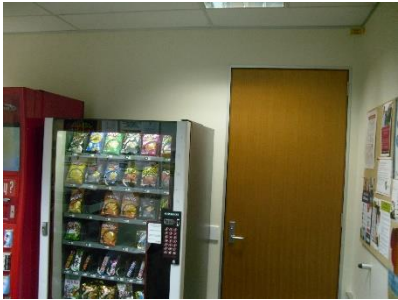
Ground Floor G.07	WALL SHEETING - NORTHERN ELEVATION , Fibrous Cement	8m ²	NAD
Similar to 3-749		Ground Floor G.07	WALL SHEETING - EASTERN AND SOUTHERN ELEVATIONS, Fibrous Cement	16m ²	NAD

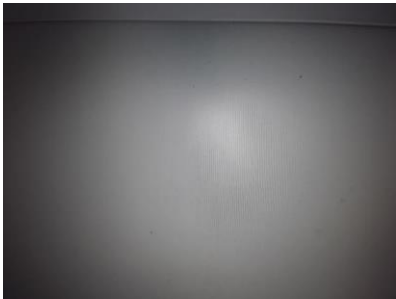
Ground Floor G.T04	WALL SHEETING - NORTHERN AND EASTERN ELEVATIONS, Fibrous Cement	16m ²	NAD
3-750

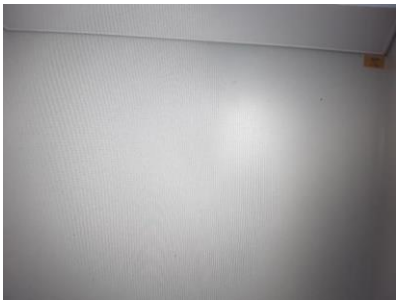
Ground Floor G.T04	WALL SHEETING - WESTERN ELEVATION , Fibrous Cement	8m ²	NAD
3-751	 	Ground Floor G.T04	WALL SHEETING - SOUTHERN ELEVATION , Fibrous Cement	8m ²	NAD

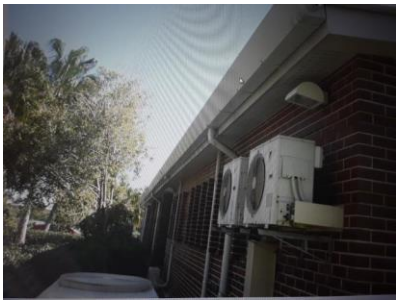
Ground Floor EXTERNAL	SOFFIT - SOUTHERN ELEVATION , Fibrous Cement	10m ²	NAD
Similar to 3-747	 	Ground Floor EXTERNAL	SOFFIT - NORTH,EASTERN AND WESTERN ELEVATIONS , Fibrous Cement	30m ²	NAD
