**ASBESTOS CONTAINING MATERIALS
SURVEY REPORT**

**BUILDING 608
PELM ADMINISTRATION
Gladstone Marina Campus
Bryan Jordan Drive, Gladstone Marina, Queensland**

Report Number 622.10968.00000/0020-R01-BLD 608-ASR

28 September 2017

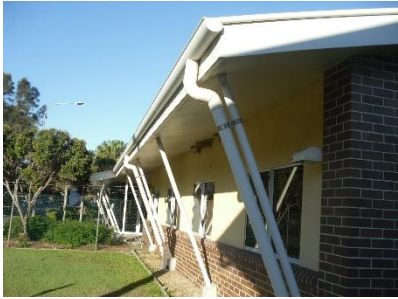
Ground Floor EXTERNAL	SOFFIT - NORTHERN ELEVATION , Fibrous Cement	30m ²	NAD
3-788

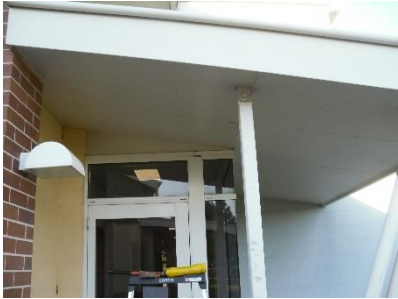
Ground Floor EXTERNAL	SOFFIT - SOUTHERN ELEVATION , Fibrous Cement	20m ²	NAD

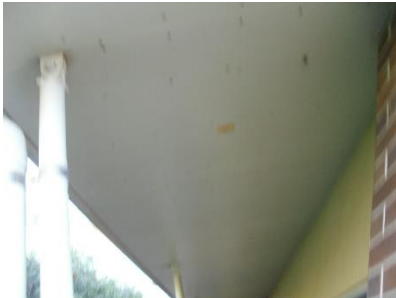
Ground Floor EXTERNAL	SOFFIT - EAST ELEVATION , Fibrous Cement	20m ²	NAD
3-789

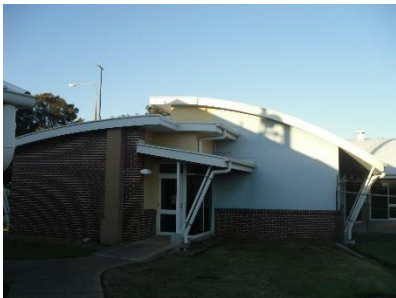
Ground Floor EXTERNAL	SOFFIT - WESTERN ELEVATION , Fibrous Cement	30m ²	NAD
