**ASBESTOS CONTAINING MATERIALS  
SURVEY REPORT**

**Grounds Shed 3  
Rockhampton City TAFE**

Report Number 622.10968.00000/0090-R01-ASR-GroundsShed3

01 November 2017

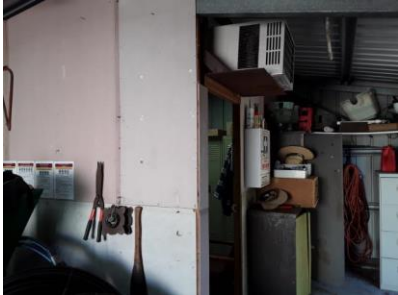
Sample No./ Visual Observation	Photo	Location			Analysis
		Int / Ext Floor Specific Location	Material Application	Extent	Result
3-938

1st Floor INTERNAL WALL SHEETING	WALL SHEETING - NORTH AND EAST ELEVATIONS , Fibrous Cement	26m <sup>2</sup>	NAD
