ASBESTOS CONTAINING MATERIALS SURVEY REPORT

Building 1
Mackay City Tafe

Report Number 622.10968.00000-0080-R01-ASR-Building 1

09 November 2017

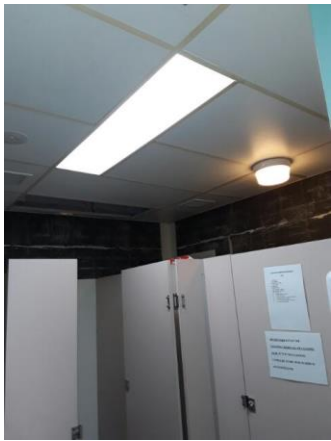
Ground Floor G24 Female toilet	Ceiling panels , Fibrous Cement	8m ²	NAD
Similar to 5-884

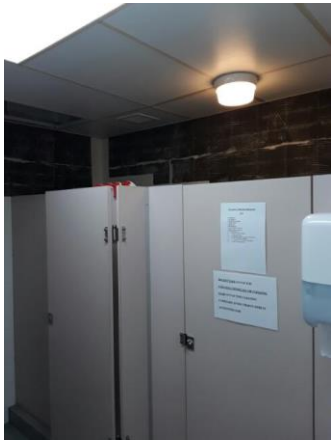
Ground Floor G23 toilet corridor	Ceiling panels , Fibrous Cement	4m ²	NAD
Previously Sampled 620.10993.00000/J7

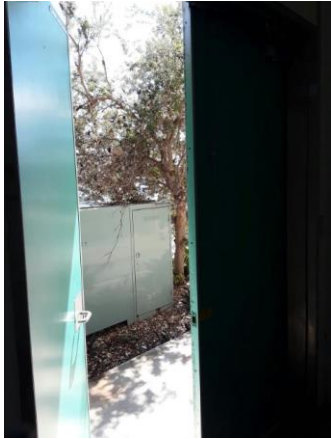
Ground Floor G.26 Battery room	Fire door, Insulation	3m ²	NAD
Previously Sampled 620.10993.00000/J6

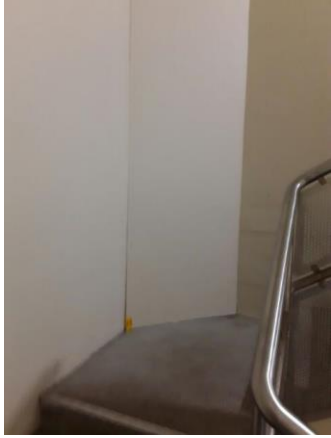
4th Floor east stairwell between floors 4 and roof	South West wall, Fibrous Cement	4m ²	NAD
