COMPLIANCE ASBESTOS RE-INSPECTION AND RISK ASSESSMENT

NOVEMBER 2021

J033441

MACKAY CITY CAMPUS_Block A Sydney Street
Sydney Street
MACKAY QLD
4740

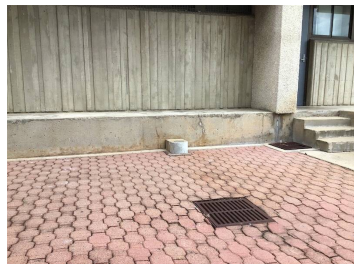
Location		Building 003 - Ground Floor - External - Drain trap surround - Moulded cement - South elevation, central section of building

Hazard Type		Asbestos	Material Assessment		Disturbance Assessment		
Friability		Non-friable	Product Type	1	Occupancy		1
Sample No.		620.10993.0000/A19 {AO000079}	Extent of damage	0	Disturbance		0
Result		Positive Chrysotile	Surface Treatment	1	Exposure		0
			Asbestos Type	1	Maintenance		0
Item Number		1	Material Score	3	Disturbance Score		1
			Priority Score	4	Very Low		
No Additional Photographic Evidence Available

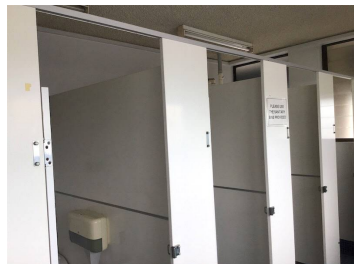
Location		Building 003 - 2nd Floor - Female Bathroom - Toilet partitions - Fibre cement sheet - Central					
Hazard Type		Asbestos		Material Assessment		Disturbance Assessment	
Friability		Non-friable		Product Type		1	
Sample No.		620.10993.0000/A13 {AO000080}		Extent of damage		0	
Result		Positive Chrysotile		Surface Treatment		1	
				Asbestos Type		1	
Item Number		2		Material Score		3	
				Priority Score		6	
						Very Low	
No Additional Photographic Evidence Available

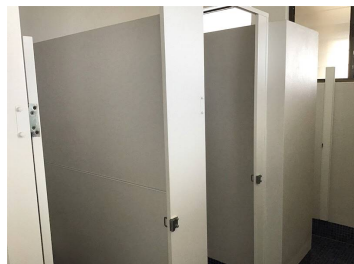
Location		Building 003 - 3rd Floor - Female Bathroom - Toilet partitions - Fibre cement - Central

Hazard Type		Asbestos	Material Assessment		Disturbance Assessment		
Friability		Non-friable	Product Type	1	Occupancy		0
Sample No.		5-902 {AO000081}	Extent of damage	0	Disturbance		1
Result		Positive Chrysotile	Surface Treatment	1	Exposure		0
			Asbestos Type	1	Maintenance		0
Item Number		3	Material Score	3	Disturbance Score		1
			Priority Score	4	Very Low		
No Additional Photographic Evidence Available

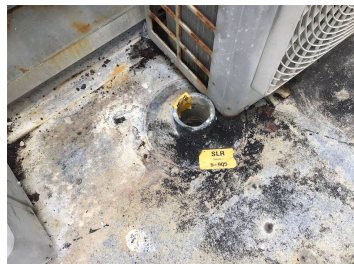
Location		Building 003 - 4th Floor - Roof Access - Floor lining - Mastic - West section, adj AC Units

Hazard Type		Asbestos	Material Assessment		Disturbance Assessment		
Friability		Non-friable	Product Type	1	Occupancy		0
Sample No.		5-905 (AO000083)	Extent of damage	0	Disturbance		0
Result		Positive Chrysotile	Surface Treatment	0	Exposure		0
			Asbestos Type	1	Maintenance		0
Item Number		7	Material Score	2	Disturbance Score		0
			Priority Score	2	Very Low		
No Additional Photographic Evidence Available

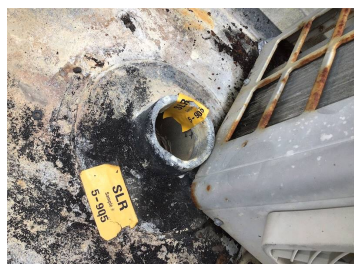
Location	Building 003 - 4th Floor - Roof Access - Drain pipe - Mastic - West section, adj AC Units

Hazard Type	Asbestos	Material Assessment	Disturbance Assessment			
Friability	Non-friable	Product Type	1		Occupancy	0
Sample No.	5-906 (AO000084)	Extent of damage	0		Disturbance	0
Result	Positive Chrysotile	Surface Treatment	0		Exposure	0
		Asbestos Type	1		Maintenance	0
Item Number	8	Material Score	2		Disturbance Score	0
		Priority Score	2		Very Low	
No Additional Photographic Evidence Available
