# COMPLIANCE ASBESTOS RE-INSPECTION AND RISK ASSESSMENT

NOVEMBER 2021

J033442

MACKAY CITY CAMPUS\_Block D Sydney Street  
Sydney Street  
MACKAY QLD  
4740

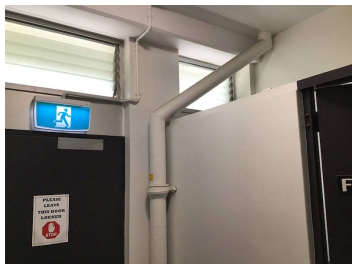
Location		Building 005 - Ground Floor - Female bathroom - Flue pipe - Moulded cement - Adj fire exit

Hazard Type		Asbestos	Material Assessment		Disturbance Assessment		
Friability		Non-friable	Product Type	1	Occupancy		0
Sample No.		5-894 {AO000085}	Extent of damage	0	Disturbance		1
Result		Positive Chrysotile	Surface Treatment	0	Exposure		0
			Asbestos Type	1	Maintenance		0
Item Number		1	Material Score	2	Disturbance Score		1
			Priority Score	3	Very Low		
No Additional Photographic Evidence Available

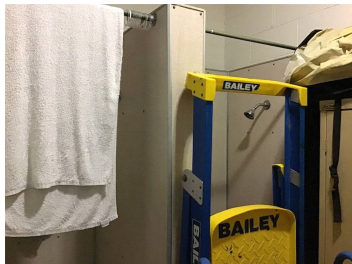
Location		Building 005 - Ground Floor - Male Shower Room - Shower lining - Tilux - Central

Hazard Type		Asbestos	Material Assessment			Disturbance Assessment	
Friability		Non-friable	Product Type	1		Occupancy	0
Sample No.		620.10993.0000/D2 {AO000086}	Extent of damage	0		Disturbance	1
Result		Positive Chrysotile	Surface Treatment	0		Exposure	0
			Asbestos Type	1		Maintenance	0
Item Number		2	Material Score	2		Disturbance Score	1
			Priority Score	3		Very Low	
No Additional Photographic Evidence Available

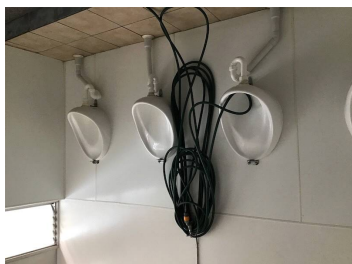
Location		Building 005 - Ground Floor - Male Bathroom - Wall lining - Tilux - East elevation, behind urinals

Hazard Type		Asbestos	Material Assessment		Disturbance Assessment		
Friability		Non-friable	Product Type	1	Occupancy		1
Sample No.		Visual	Extent of damage	0	Disturbance		1
Result		Assumed Positive Unknown or Crocidolite	Surface Treatment	0	Exposure		0
			Asbestos Type	3	Maintenance		0
Item Number		3	Material Score	4	Disturbance Score		2
			Priority Score	6	Very Low		
No Additional Photographic Evidence Available

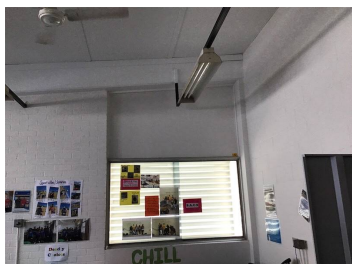
Location		Building 005 - 1st Floor - Room - Upper infill panel - Fibre cement sheet - West elevation			
Hazard Type		Asbestos	Material Assessment		Disturbance Assessment
Friability	Non-friable	Product Type	1	Occupancy	0
Sample No.	5-909 (AO000087)	Extent of damage	0	Disturbance	1
Result	Positive Chrysotile	Surface Treatment	0	Exposure	0
		Asbestos Type	1	Maintenance	0
Item Number	4	Material Score	2	Disturbance Score	1
		Priority Score	3	Very Low	
No Additional Photographic Evidence Available

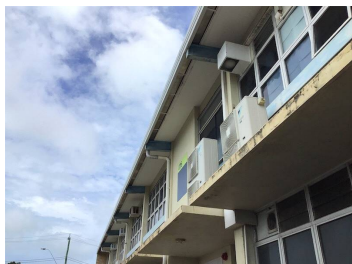
Location		Building 005 - 1st Floor - External - Eaves - Fibre cement sheet - North & South elevation

Hazard Type		Asbestos	Material Assessment		Disturbance Assessment		
Friability		Non-friable	Product Type	1	Occupancy		0
Sample No.		620.10993.0000/D11 {AO000088}	Extent of damage	0	Disturbance		1
Result		Positive Chrysotile	Surface Treatment	2	Exposure		0
			Asbestos Type	1	Maintenance		0
Item Number		6	Material Score	4	Disturbance Score		1
			Priority Score	5	Very Low		
No Additional Photographic Evidence Available
