COMPLIANCE ASBESTOS RE-INSPECTION AND RISK ASSESSMENT

NOVEMBER 2021

J033443

MACKAY CITY CAMPUS_Block E Sydney Street
Sydney Street
MACKAY QLD
4740

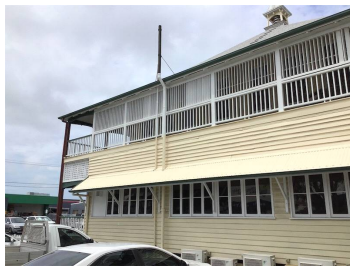
Location		Building 006 - Ground Floor - External - Flue pipe - Moulded fibre cement - West elevation

Hazard Type		Asbestos	Material Assessment		Disturbance Assessment		
Friability		Non-friable	Product Type	1	Occupancy		0
Sample No.		5-899 {AO000089}	Extent of damage	0	Disturbance		1
Result		Positive Chrysotile	Surface Treatment	1	Exposure		0
			Asbestos Type	1	Maintenance		0
Item Number		1	Material Score	3	Disturbance Score		1
			Priority Score	4	Very Low		
No Additional Photographic Evidence Available

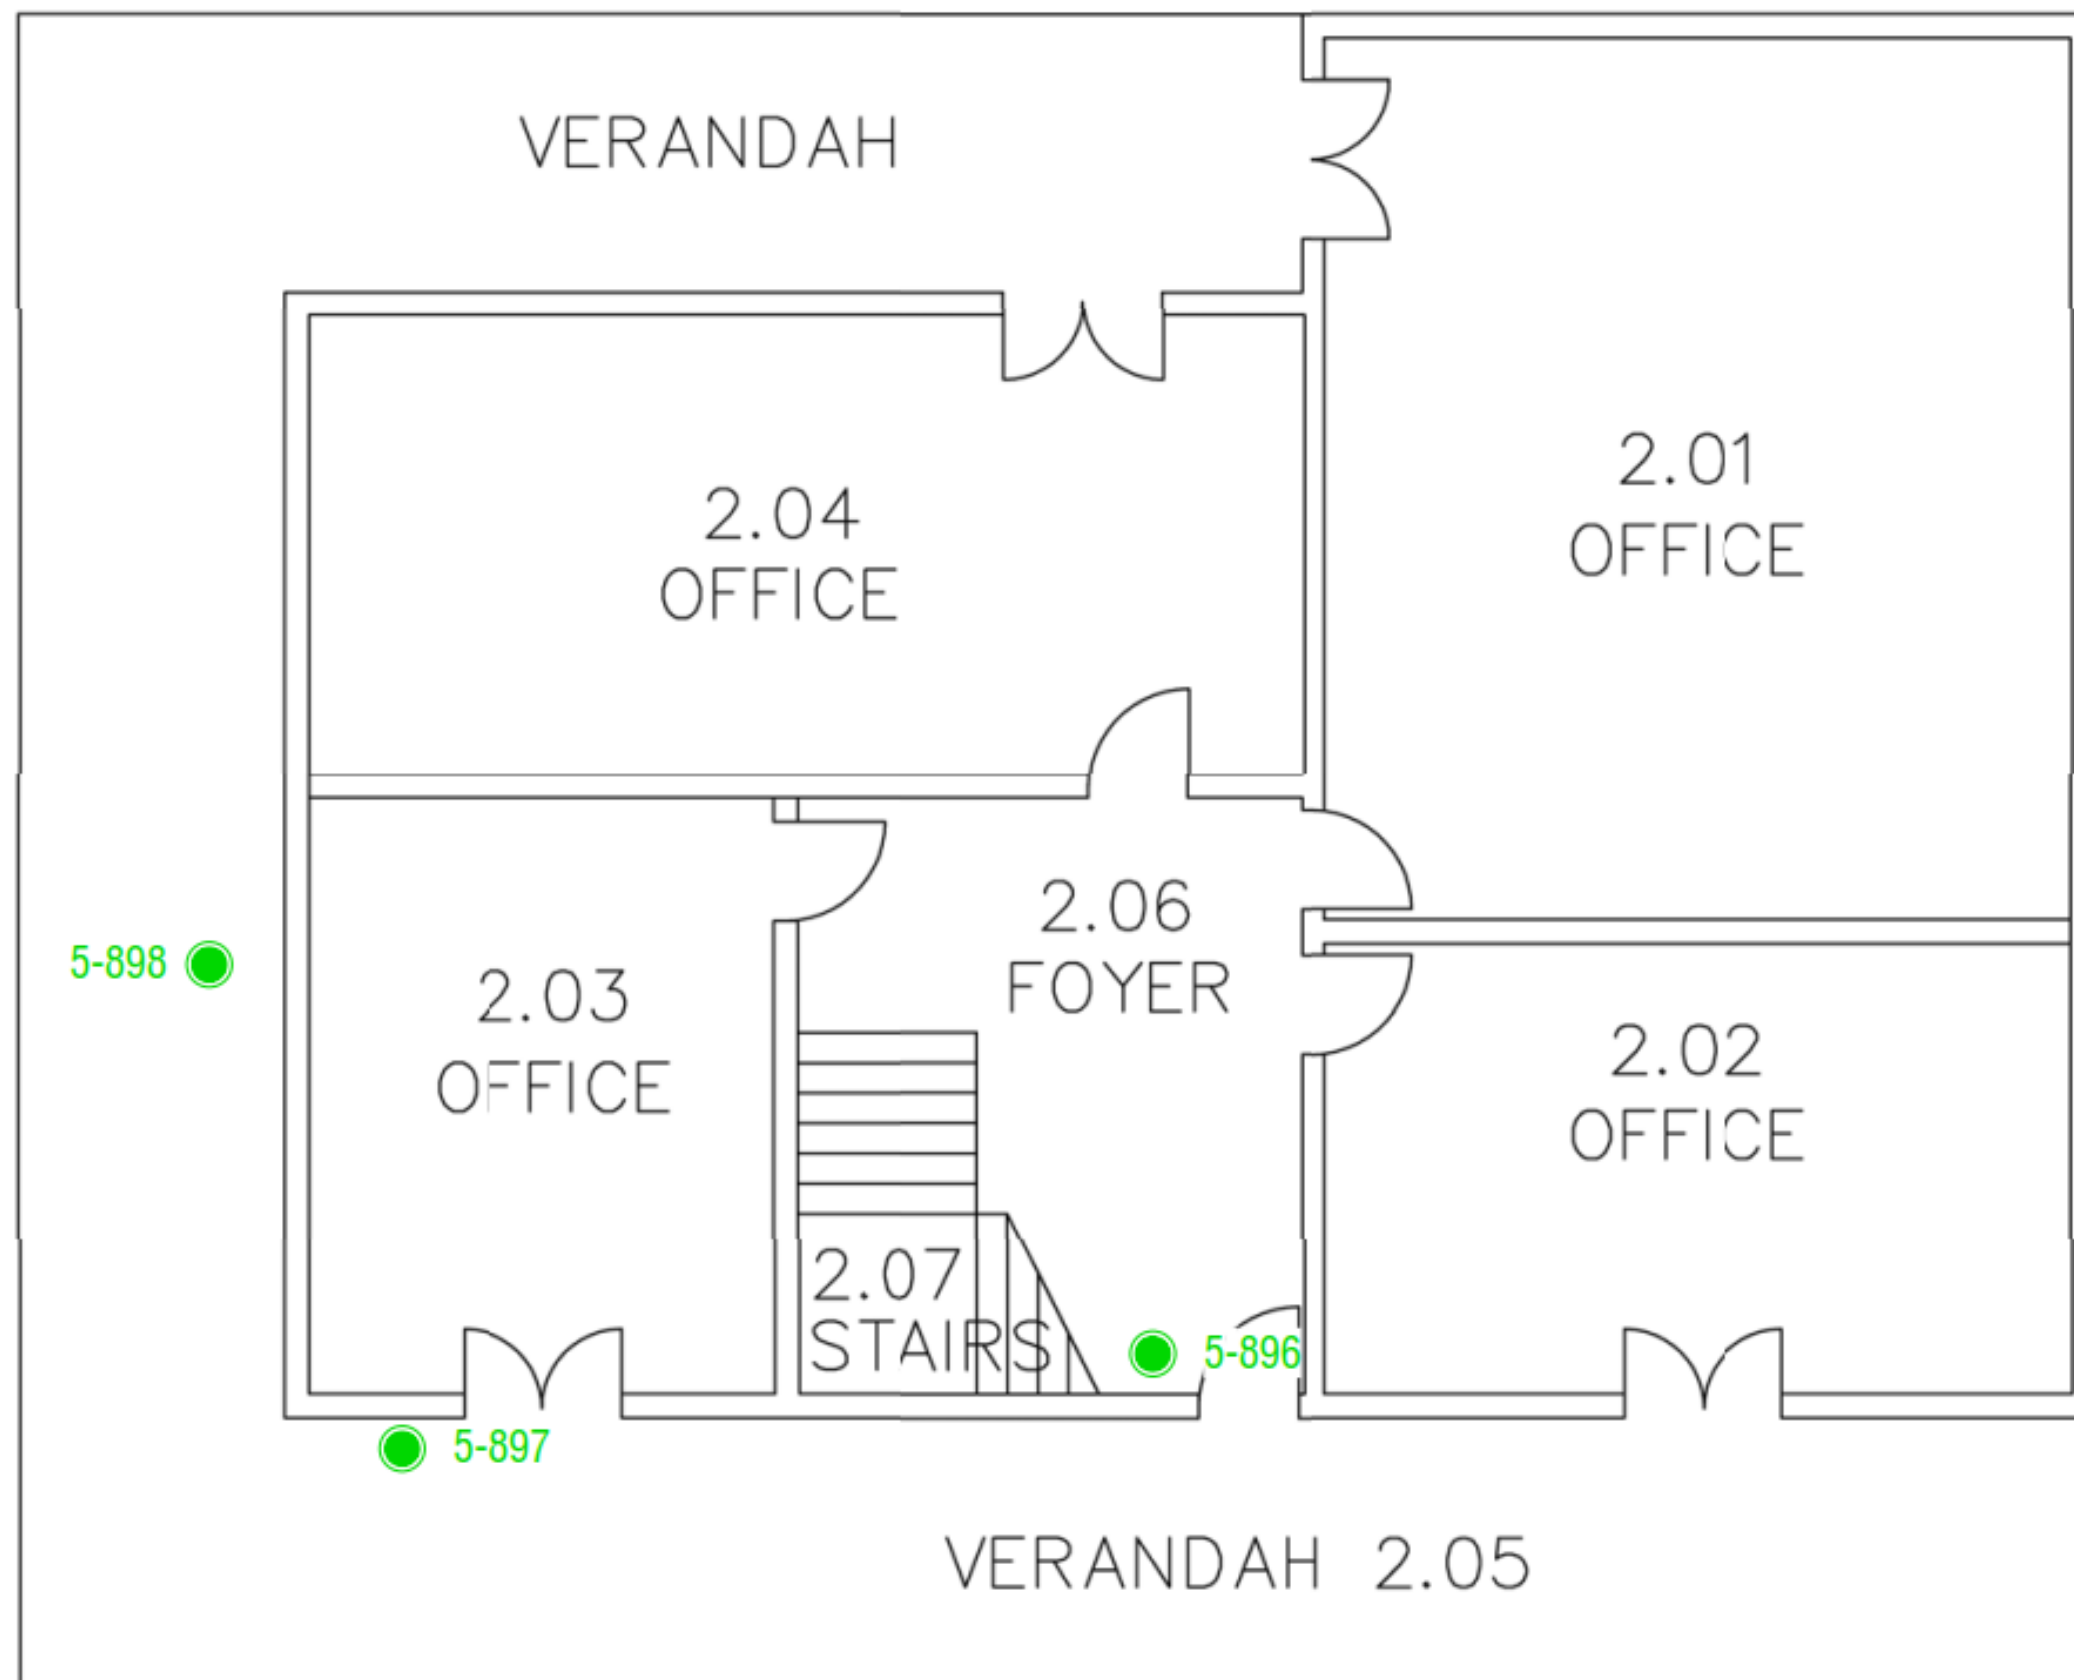
AREA: Building 6 – Level One

5-898 ●

● 5-897

● 5-896
