**ASBESTOS CONTAINING MATERIALS  
SURVEY REPORT**

**Building 701 Administration / Teaching Centre  
Mackay Ooralea Campus**

Report Number 622.10968.00000/0030-R01-ASR-BLD701

23 October 2017

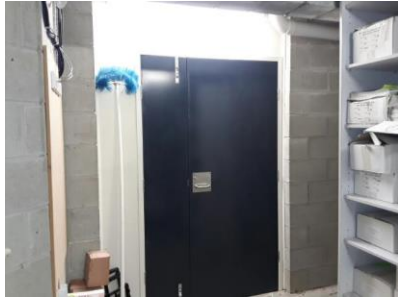
Ground Floor GP04	wall around eastern door, Fibrous Cement	2m <sup>2</sup>	NAD
5-879

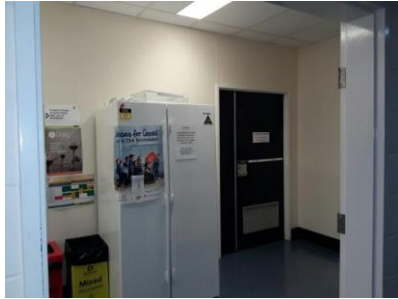
Ground Floor GP04 kitchenette	Wall- sth and west, Fibrous Cement	15m <sup>2</sup>	NAD

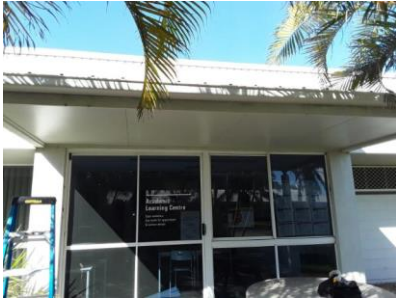
Ground Floor External- Porch outside G40	Ceiling, Fibrous Cement	8m <sup>2</sup>	NAD
5-881

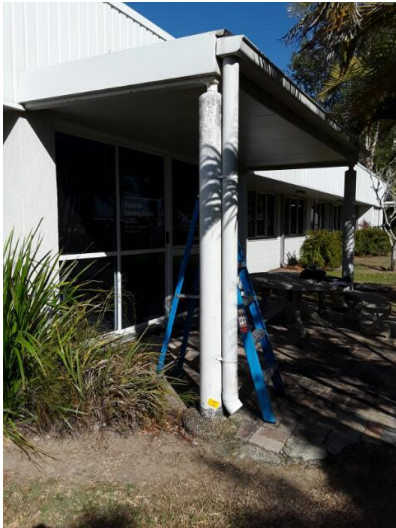
Ground Floor External	column cases, Fibrous Cement	2.5lin m	NAD

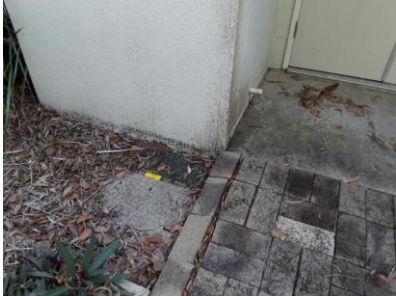
Ground Floor External	Pit casting ,	<1m <sup>2</sup>	NAD
