**ASBESTOS CONTAINING MATERIALS
SURVEY REPORT**

**Building 702 DFM Workshop
Mackay Ooralea Campus**

Report Number 622.10968.00000/0030-R01-ASR-BLD 702

19 October 2017

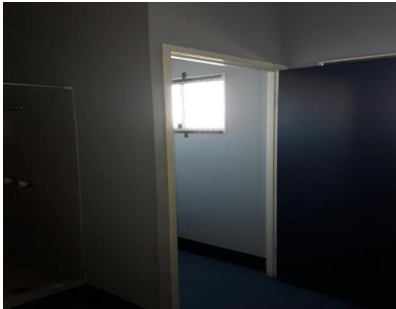
Ground Floor Unisex Toilet/shower	Wall, Fibrous Cement	36m ²	NAD
5-872

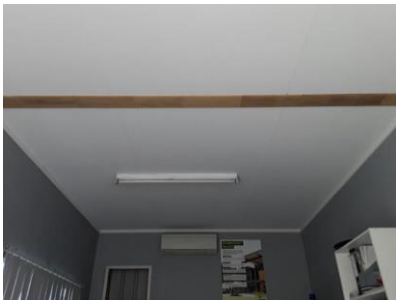
Ground Floor Kitchen	Ceiling, Fibrous Cement	21m ²	NAD

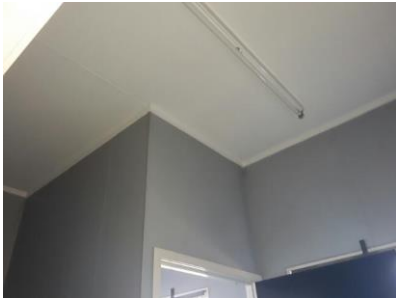
Ground Floor Unisex Toilet/shower	Ceiling, Fibrous Cement	8m ²	NAD
5-873

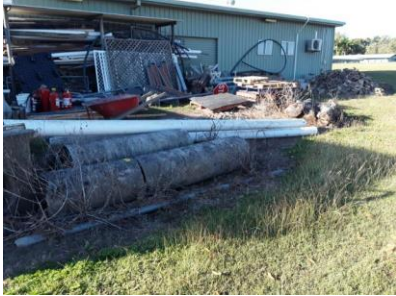
Ground Floor External	redundant pipes, Fibrous Cement	4lin m	NAD
