## ASBESTOS CONTAINING MATERIALS SURVEY REPORT

Building 703 Hannah Drysdale Building  
Mackay Ooralea Campus

Report Number 622.10968.00000/0030-R01-ASR-BLD703

19 October 2017

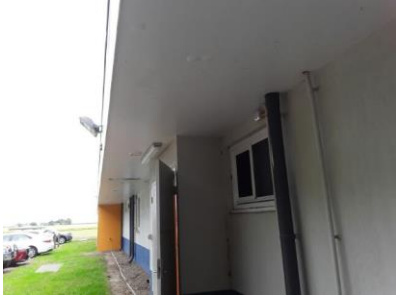
Ground Floor External	Soffit, Fibrous Cement	90m <sup>2</sup>	NAD
5-862

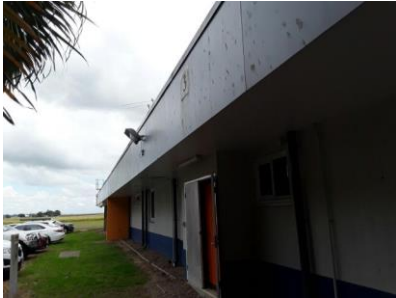
Ground Floor External	Fascia , Fibrous Cement	120m <sup>2</sup>	NAD

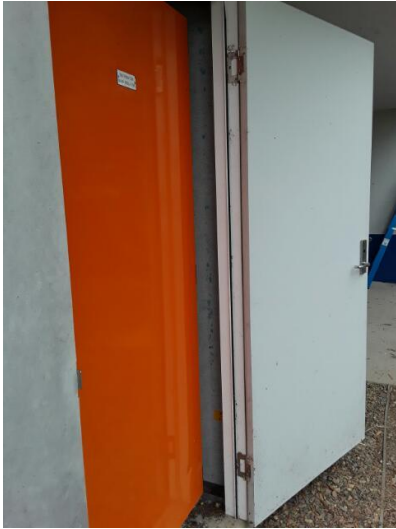
Ground Floor Switchboard room	East wall, Fibrous Cement	4m²	NAD
Similar to 5-863	 	Ground Floor Pump room- western end of building	Wall, Fibrous Cement	6m²	NAD

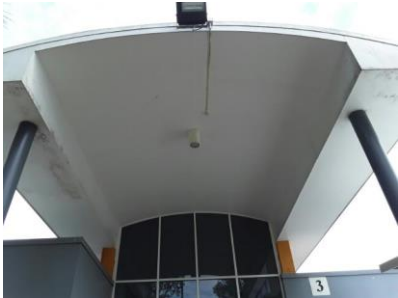
Ground Floor External	Entrance ceiling , Fibrous Cement	15m <sup>2</sup>	NAD
5-864

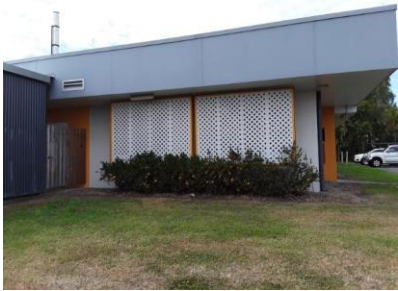
Ground Floor External	Window Shade / Lattice work, Fibrous Cement	12m <sup>2</sup>	NAD
