**ASBESTOS CONTAINING MATERIALS
SURVEY REPORT**

**Building 704 DFM Building
Mackay Ooralea Campus**

Report Number 622.10968.00000/0030-R01-ASR-BLD704

19 October 2017

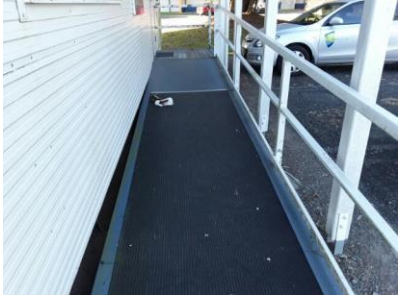
Ground Floor External	Entrance ramp, Fibrous Cement	10m ²	NAD
5-875

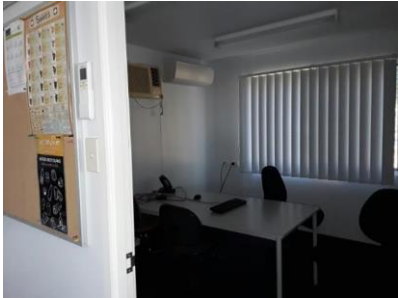
Ground Floor Office	Wall, Fibrous Cement	104m ²	NAD

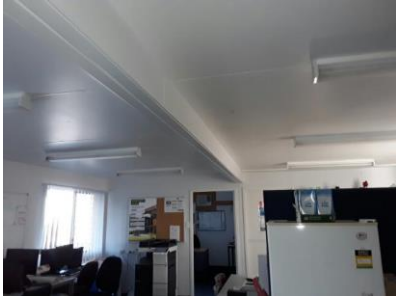
Ground Floor Entire building	Ceiling, Fibrous Cement	80m ²	NAD
