**ASBESTOS CONTAINING MATERIALS
SURVEY REPORT**

**Building 705 Student Refectory
Mackay Ooralea Campus**

Report Number 622.10968.00000/0030-R01-ASR-BLD705

19 October 2017

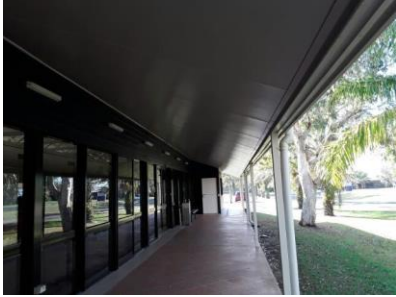
Ground Floor External	Soffit, Fibrous Cement	60m ²	NAD
5-877

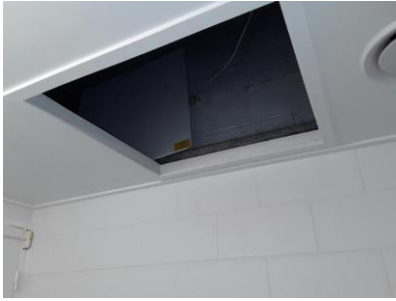
Ground Floor G-08 Disable Toilet	Ceiling access panel, Fibrous Cement	<1m ²	NAD

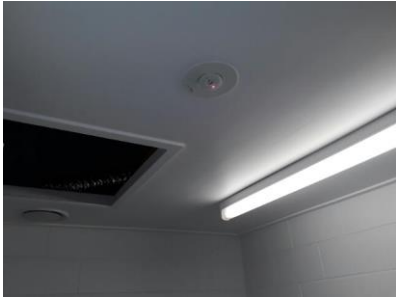
Ground Floor G-08 Disable Toilet	Ceiling, Fibrous Cement	4m ²	NAD
Similar to 5-877

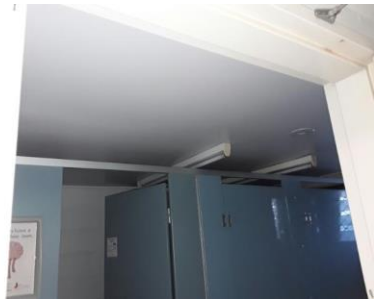
Ground Floor G-09 Female Toilets	Ceiling, Fibrous Cement	8m ²	NAD
Similar to 5-877

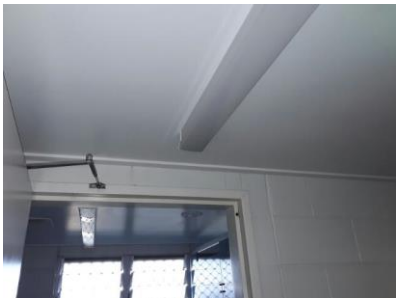
Ground Floor G-10 Male Toilets	Ceiling, Fibrous Cement	8m ²	NAD

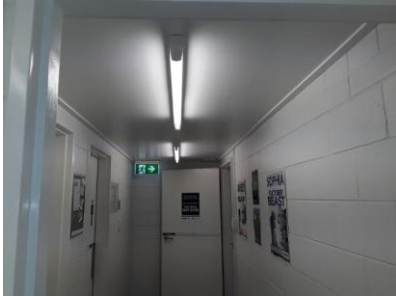
Ground Floor G-07 Corridor to Toilets	Ceiling, Fibrous Cement	8m ²	NAD
