**ASBESTOS CONTAINING MATERIALS
SURVEY REPORT**

**Building 706 Academic Building B
Mackay Ooralea Campus**

Report Number 622.10968.00000/0030-R01-ASR-BLD706

19 October 2017

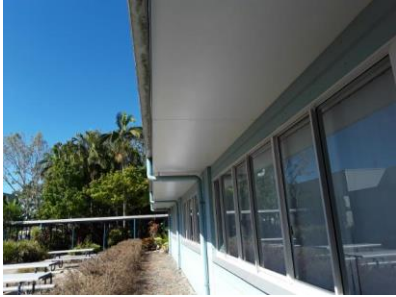
Ground Floor External	Soffit, Fibrous Cement	90m ²	NAD
5-867

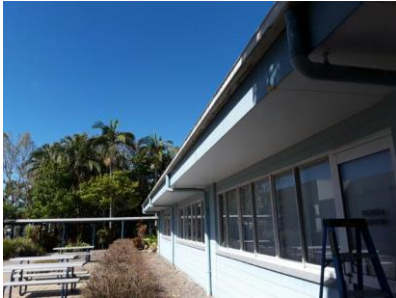
Ground Floor External	Fascia , Fibrous Cement	70m ²	NAD
