**ASBESTOS CONTAINING MATERIALS
SURVEY REPORT**

**Building 711 Demountable
Mackay Ooralea Campus**

Report Number 622.10968.00000/0030-R01-ASR-BLD711

19 October 2017

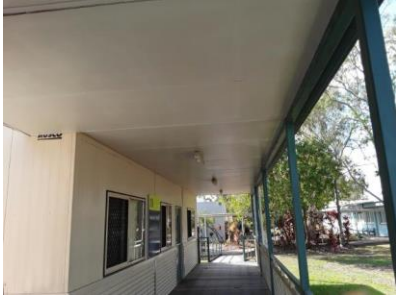
Ground Floor External	Porch Ceiling, Fibrous Cement	10m ²	NAD
Similar to 5-860

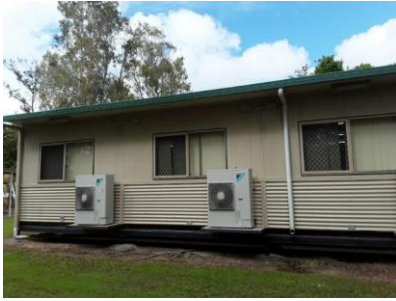
Ground Floor External	Eave, Fibrous Cement	8m ²	NAD

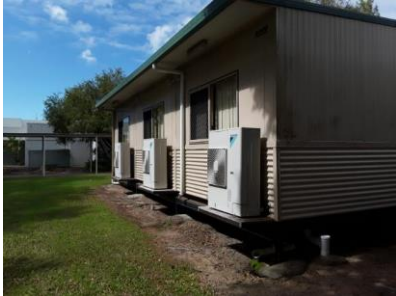
Sample No./ Visual Observation	Photo	Location			Analysis
		Int / Ext Floor Specific Location	Material Application	Extent	Result
Similar to 5-865 (sampled in building 712 adjacent dismountable)

Ground Floor External	Base sheets for Air con units, Fibrous Cement	3m ²	NAD
