ASBESTOS CONTAINING MATERIALS SURVEY REPORT

Building 712 Demountable
Mackay Ooralea Campus

Report Number 622.10968.00000/0030-R01-ASR-BLD712

19 October 2017

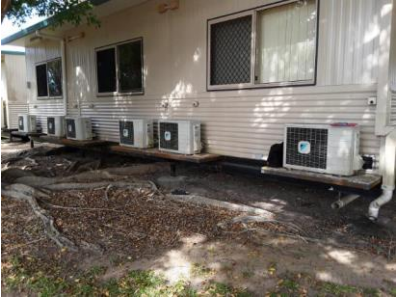
Sample No./ Visual Observation	Photo	Location			Analysis
		Int / Ext Floor Specific Location	Material Application	Extent	Result
5-865

Ground Floor External	Base sheets for Air con units, Fibrous Cement	6m ²	NAD
