## ASBESTOS CONTAINING MATERIALS SURVEY REPORT

Building 720 Bookshop & Chiropractic  
Mackay Ooralea Campus

Report Number 622.10968.00000/0030-R01-ASR-BLD720

19 October 2017

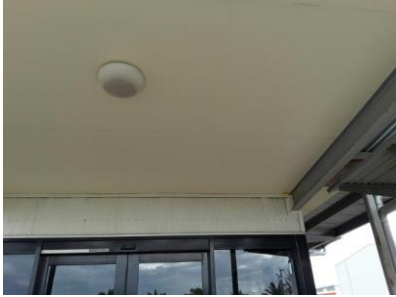
Sample No./ Visual Observation	Photo	Location			Analysis
		Int / Ext Floor Specific Location	Material Application	Extent	Result
5-858

Ground Floor External	Soffit, Fibrous Cement	15	NAD
Similar to 5-857 Sampled in Building 721

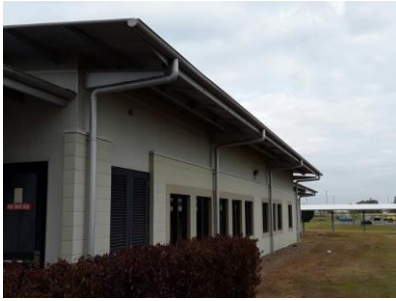
Ground Floor External	Fascia , Fibrous Cement	45m <sup>2</sup>	NAD
