**ASBESTOS CONTAINING MATERIALS
SURVEY REPORT**

**Building 721 Conservatorium
Mackay Ooralea Campus**

Report Number 622.10968.00000/0030-R01-ASR-BLD721

19 October 2017

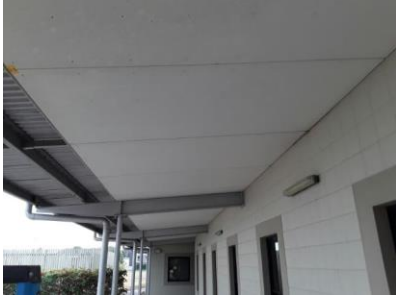
Ground Floor External	Soffit, Fibrous Cement	60m ²	NAD
5-857	 	Ground Floor External	Fascia , Fibrous Cement	60m ²	NAD
