**ASBESTOS CONTAINING MATERIALS  
SURVEY REPORT**

**Building 722 Studio Office  
Mackay Ooralea Campus**

Report Number 622.10968.00000/0030-R01-ASR-BLD722

19 October 2017

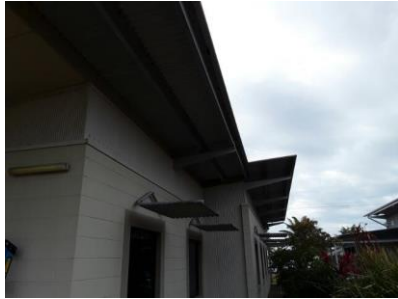
Sample No./ Visual Observation	Photo	Location			Analysis
		Int / Ext Floor Specific Location	Material Application	Extent	Result
5-859	 	Ground Floor External	porch entrance, Fibrous Cement	4m <sup>2</sup>	NAD
Similar to 5-857 Sampled in Building 721

Ground Floor External	Fascia , Fibrous Cement	30m <sup>2</sup>	NAD
