**ASBESTOS CONTAINING MATERIALS
SURVEY REPORT**

**Building 750 Campus Reception /Security
Mackay Ooralea Campus**

Report Number 622.10968.00000/0030-R01-ASR-BLD750

19 October 2017

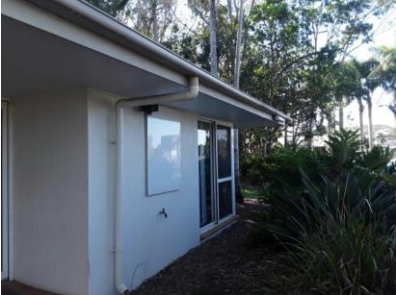
Sample No./ Visual Observation	Photo	Location			Analysis
		Int / Ext Floor Specific Location	Material Application	Extent	Result
Similar to 5-853

Ground Floor External	Eave, Fibrous Cement	55m ²	NAD
