Report Number 622.10968.00000/0030-R01 ASR-BLD750

CQ University Asbestos Audits

MACKAY OORALEA CAMPUS

Campus Reception / Security
Boundary Road, Mackay,
QLD 4740

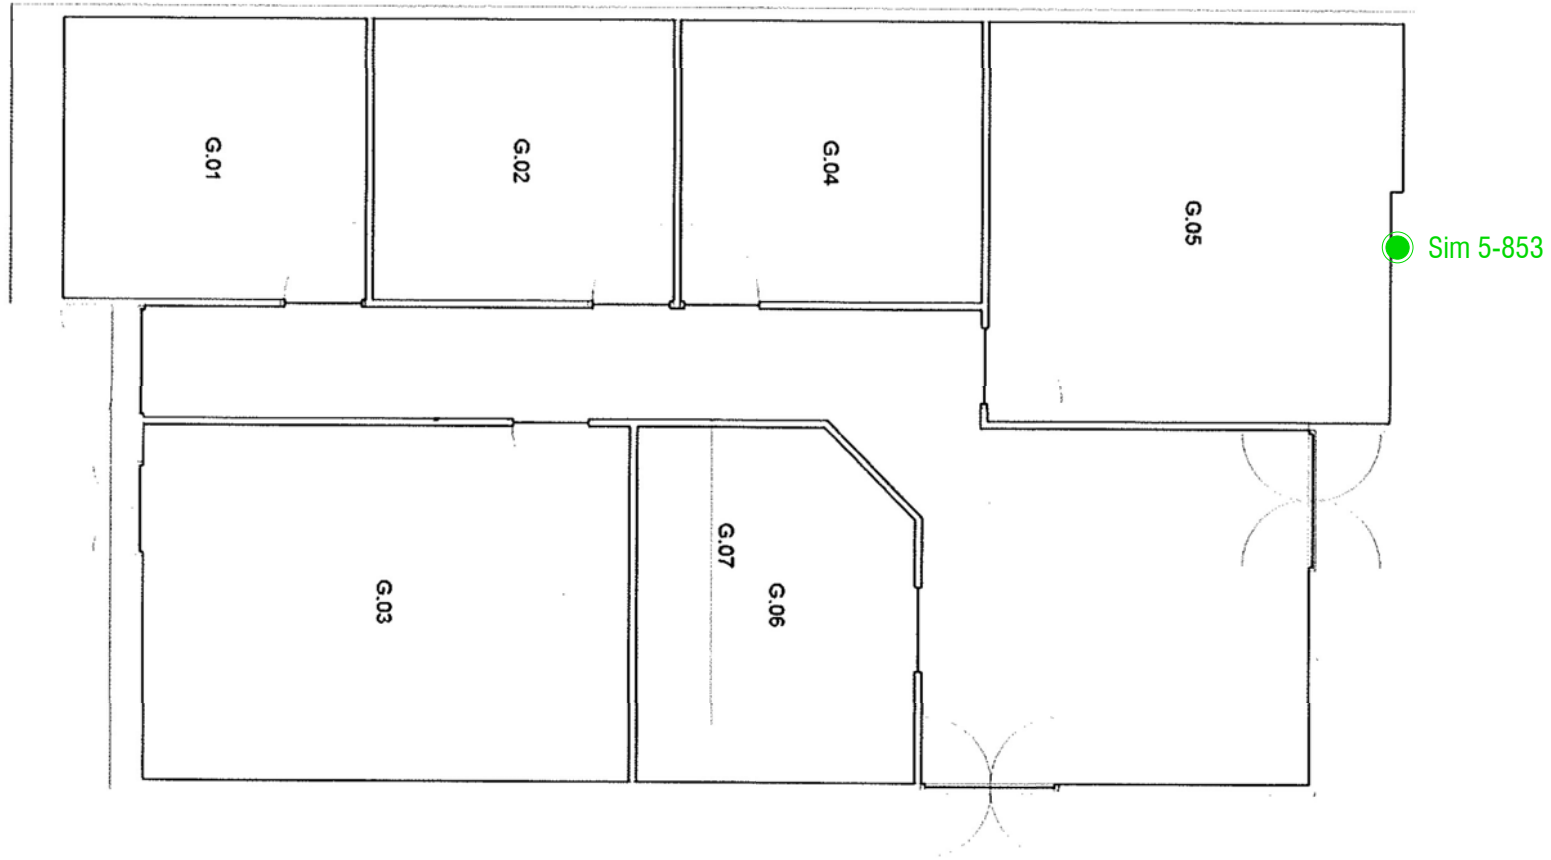
Building No:	750
Inspection Date:	2/08/17 - 4/08/17
Inspected By:	NC
Figure No.:	SLR62210968-750-01
Drawn By:	LF
Drawn Date:	24/10/17

Sample location
No Asbestos Detected
