ASBESTOS CONTAINING MATERIALS SURVEY REPORT

Building 751 Dining and Conference Room A
Mackay Ooralea Campus

Report Number 622.10968.00000/0030-R01-ASR-BLD751

19 October 2017

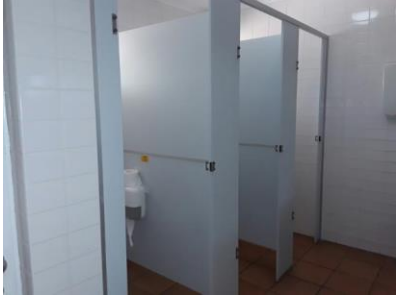
Ground Floor Female Toilets	Toilet partitions, Fibrous Cement	10m ²	NAD
5-853

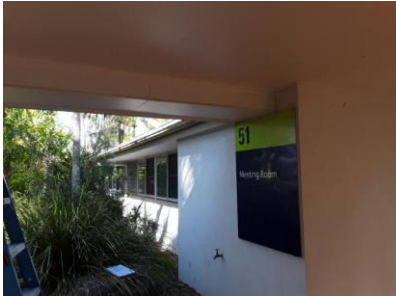
Ground Floor External	Eave, Fibrous Cement	60m ²	NAD

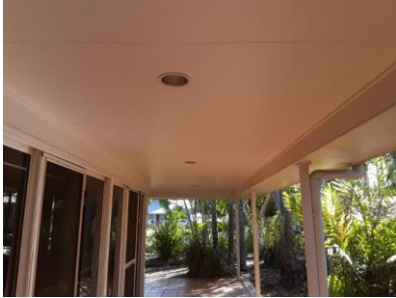
Ground Floor External	Walk way ceiling, Fibrous Cement	25m ²	NAD
