ASBESTOS CONTAINING MATERIALS SURVEY REPORT

Building 752 Accommodation Unit B
Mackay Ooralea Campus

Report Number 622.10968.00000/0030-R01-ASR-Building 752

19 October 2017

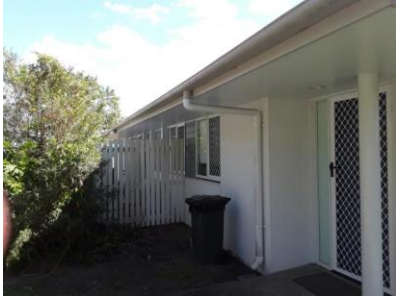
Ground Floor External	Eave, Fibrous Cement	46m ²	NAD
