ASBESTOS CONTAINING MATERIALS SURVEY REPORT

Building 753 Accommodation Unit C
Mackay Ooralea Campus

Report Number 622.10968.00000/0030-R01-ASR-BLD753

19 October 2017

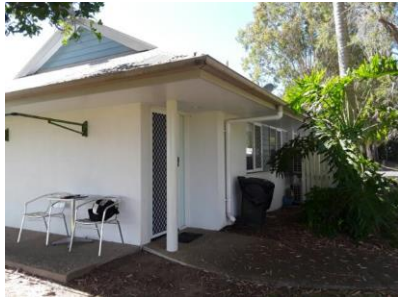
Sample No./ Visual Observation	Photo	Location			Analysis
		Int / Ext Floor Specific Location	Material Application	Extent	Result
5-843

Ground Floor External	Eave, Fibrous Cement	46m ²	NAD
