ASBESTOS CONTAINING MATERIALS SURVEY REPORT

Building 754 Accommodation Unit D
Mackay Ooralea Campus

Report Number 622.10968.00000/0030-R01-ASR-BLD754

19 October 2017

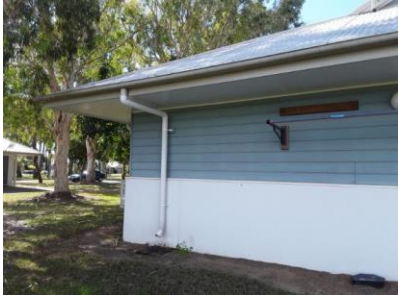
Sample No./ Visual Observation	Photo	Location			Analysis
		Int / Ext Floor Specific Location	Material Application	Extent	Result
5-842

Ground Floor External	Eave,	56m ²	NAD
