**ASBESTOS CONTAINING MATERIALS
SURVEY REPORT**

**Building 756 Accommodation Unit F
Mackay Ooralea Campus**

Report Number 622.10968.00000/0030-R01-ASR-BLD756

19 October 2017

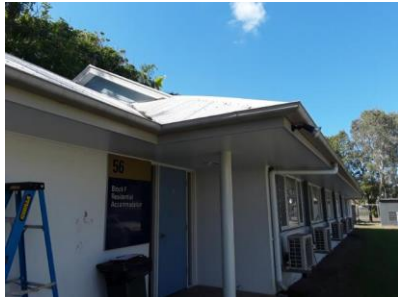
Ground Floor External	Eave, Fibrous Cement	46m ²	NAD
