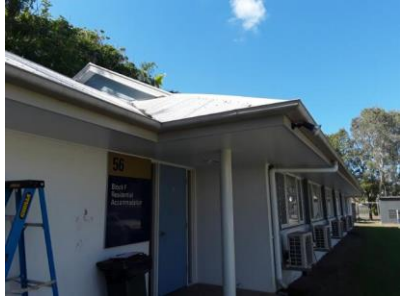
Sample No./ Visual Observation	Photo	Location			Analysis
		Int / Ext Floor Specific Location	Material Application	Extent	Result
5-848

Ground Floor External	Eave, Fibrous Cement	46m <sup>2</sup>	NAD
