## ASBESTOS CONTAINING MATERIALS SURVEY REPORT

Building 757 Accommodation Unit G  
Mackay Ooralea Campus

Report Number 622.10968.00000/0030-R01-ASR-BLD757

19 October 2017

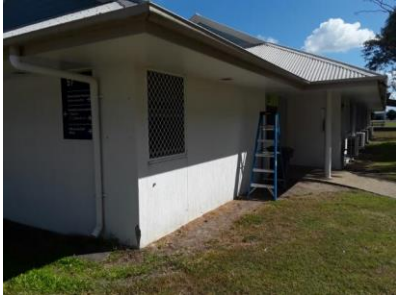
Ground Floor External	Eave, Fibrous Cement	46m <sup>2</sup>	NAD
