**ASBESTOS CONTAINING MATERIALS  
SURVEY REPORT**

**Building 758 Private Use Building  
Mackay Ooralea Campus**

Report Number 622.10968.00000/0030-R01-ASR-BLD758

19 October 2017

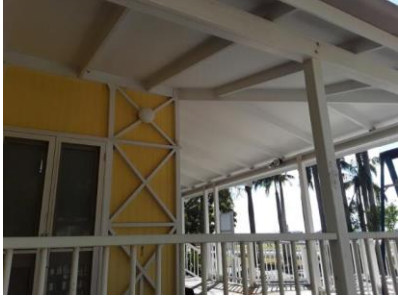
Ground Floor External	Porch Eave, Fibrous Cement	55m <sup>2</sup>	NAD
5-850

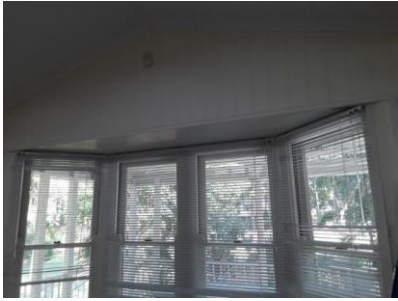
Ground Floor Open area south side of kitchen	Small section ceiling, Fibrous Cement	2m <sup>2</sup>	NAD

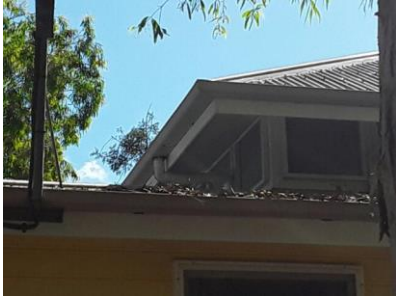
Ground Floor External	upper eave, Fibrous Cement	20m <sup>2</sup>	NAD
