**ASBESTOS CONTAINING MATERIALS  
SURVEY REPORT**

**Building 761 Fire Pump shed  
Mackay Ooralea Campus**

Report Number 622.10968.00000/0030-R01-ASR-BLD761

19 October 2017

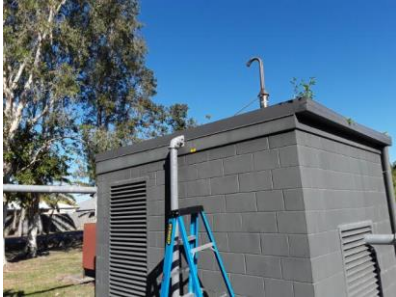
Sample No./ Visual Observation	Photo	Location			Analysis
		Int / Ext Floor Specific Location	Material Application	Extent	Result
5-854		Ground Floor internal	pipe lining, Woven Product	5lin m	NAD
5-855

Ground Floor External	upper infill, Fibrous Cement	2m²	NAD
