# COMPLIANCE ASBESTOS RE-INSPECTION AND RISK ASSESSMENT

NOVEMBER 2021

J033464

ROCKHAMPTON NORTH CAMPUS\_QR Rolling Stock  
Bruce Highway  
ROCKHAMPTON NORTH QLD  
4700

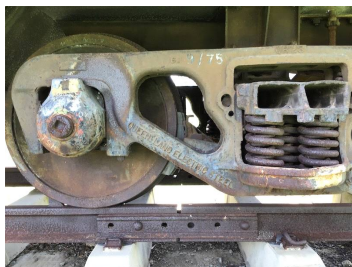
| Location | | QR Rail Carriage - Ground Floor - Old Coal Train Carriage - 8Brake pads - Friction material | | | | |
| Result | | Positive Chrysotile | Surface Treatment | 1 | Exposure | 0 |
| Item Number | | 1 | Material Score | 3 | Disturbance Score | 0 |
| | | | Priority Score | 3 | Very Low | |

| Item No | Location / Description | Hazard Type | Sample No. | Item Status | Est. Extent | Current Label | Condition | Friability | Disturbance Risk | Material Risk | Control Priority | Recommended Action | Record of Works |
|---|--|---|---|---|---|---|---|---|---|---|---|---|---|
| | Brake pads -Friction material | Asbestos | 1-518 {AO000185} | Identified, Positive | 8no. | No | Good Condition | Friable | Very Low | Very Low | P4 | Manage In Situ | |
