ASBESTOS CONTAINING MATERIALS SURVEY REPORT

VC's Residence (Residential Precinct)
Building 056
Rockhampton North

Report Number 622.10968.00000/0040-R01-ASR-Bld56

19 January 2018

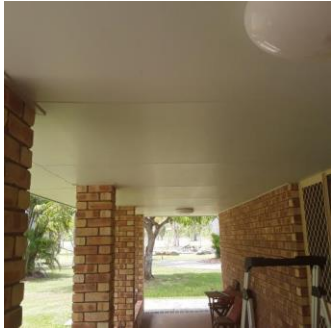
Ground Floor NORTHERN PORCH	Ceiling sheeting , Fibrous Cement	24m ²	NAD
Similar to 1-707

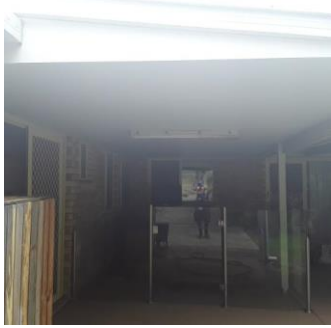
Ground Floor SOUTHERN PORCH	Ceiling sheeting , Fibrous Cement	m ²	NAD

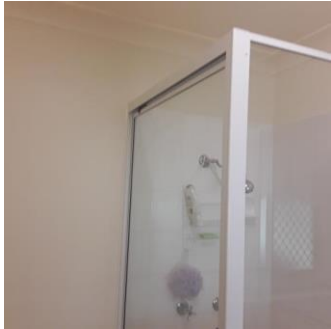
Ground Floor NORTH WESTERN BATHROOM	Western wall sheeting , Fibrous Cement	5m ²	NAD
Similar to 1-708

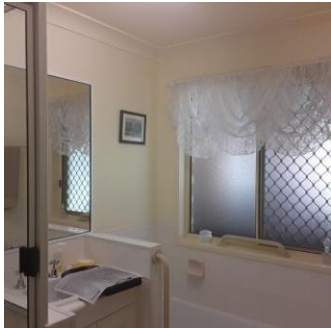
Ground Floor NORTH WESTERN BATHROOM	Eastern, southern and western wall sheeting , Fibrous Cement	15m ²	NAD

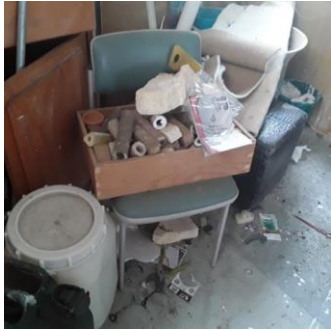
Ground Floor GARAGE SHED	Eastern elevation kiln bricks , Fibrous Cement	0.5 m ²	NAD
Similar to 1-710

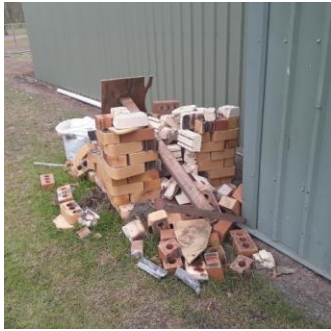
Ground Floor GARAGE SHED	Southern elevation fire brick, Fibrous Cement	1m ²	NAD

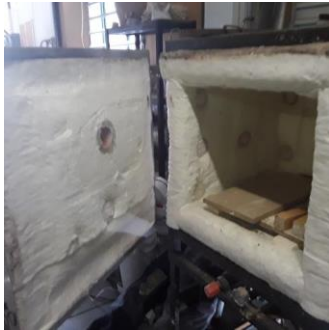
Ground Floor GARAGE SHED	Eastern elevation kiln ., Fibrous Cement	1m ²	NAD
1-712

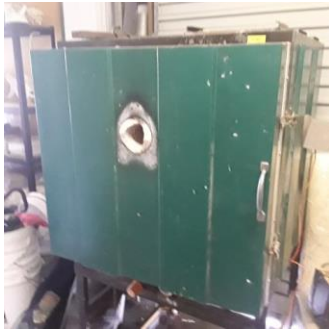
Ground Floor GARAGE SHED	Eastern elevation kiln .external door protuding , Fibrous Cement	1m ²	NAD
