ASBESTOS CONTAINING MATERIALS SURVEY REPORT

Gymnasium (Residential Precinct)
Building 057
Rockhampton North

Report Number 622.10968.00000/0040-R01-ASR-Bld 57

19 January 2018

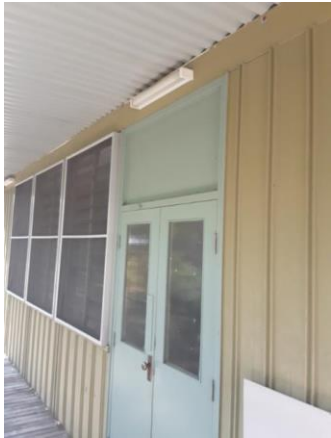
Sample No./ Visual Observation	Photo	Location			Analysis
		Int / Ext Floor Specific Location	Material Application	Extent	Result
1-287

External Office	External wall - infill above doors,	2m ²	NAD

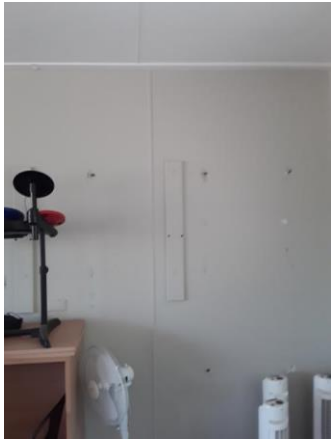
Sample No./ Visual Observation	Photo	Location			Analysis
		Int / Ext Floor Specific Location	Material Application	Extent	Result
1-288

Ground Floor internal wall	Internal wall,	60m ²	NAD
