## ASBESTOS CONTAINING MATERIALS SURVEY REPORT

Beatrice Hutton House (Residential Precinct)  
Building 068  
Rockhampton North

068Report Number 622.10968.00000/0040-R01-ASR-BLD068

27 December 2017

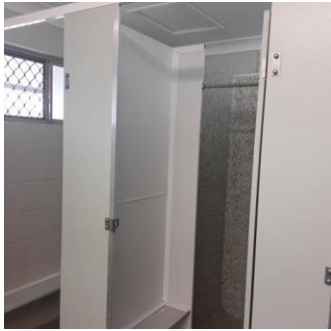
GROUND FLOOR FEMALE ABLUTIONS AND SHOWERS	Shower and toilet cubicle partitions , Fibrous Cement	3no	NAD
Similar to 1-691	 	GROUND FLOOR MALE ABLUTIONS AND SHOWERS	Shower and toilet cubicle partitions , Fibrous Cement	3no	NAD

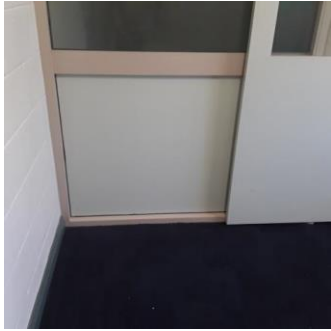
1st Floor ROOM 23 ( RESIDENTIAL ADVISOR )	Infill panel to north wall , Fibrous Cement	1no	NAD
Similar to 1-691

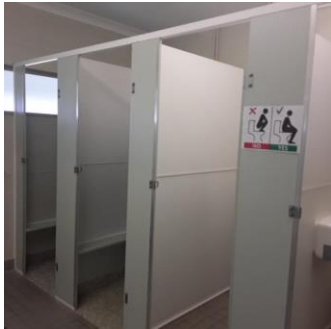
1st Floor UNISEX LEVEL 1 ABLUTIONS AND SHOWERS	Shower and toilet cubicle partitions , Fibrous Cement	3no	NAD

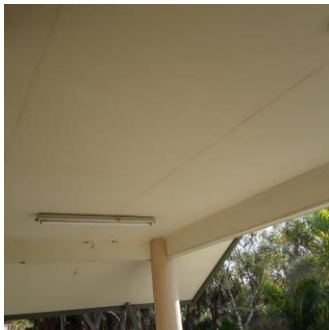
1st Floor EXTERNAL.	Northern elevation. ceiling to open stairwell , Fibrous Cement	32m²	NAD

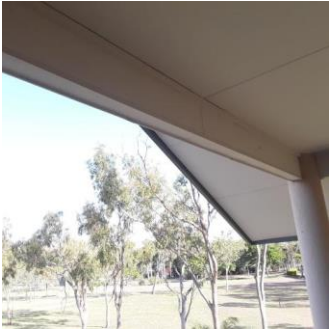
1st Floor EXTERNAL.	Southern and northern elevation. bulkhead linings to open stairwells., Fibrous Cement	2no	NAD
Similar to 1-693

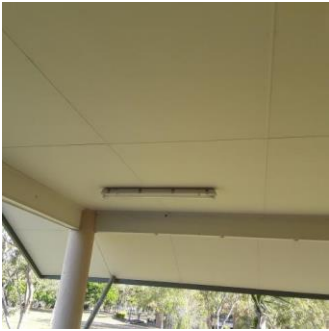
1st Floor EXTERNAL.	Southern elevation. ceiling to open stairwell , Fibrous Cement	32m²	NAD

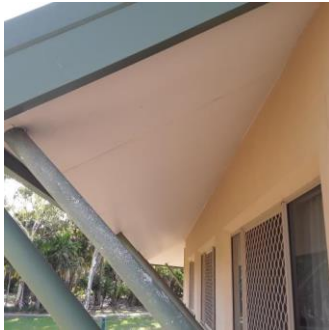
Ground Floor EXTERNAL	Soffits. All elevations. , Fibrous Cement	160m <sup>2</sup>	NAD
Similar to 1-694

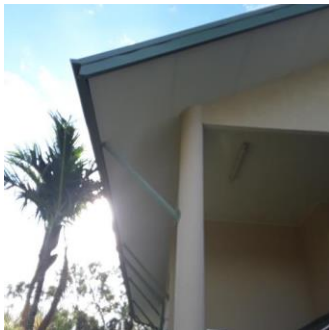
1st Floor EXTERNAL	Soffits. level 1. all elevations. , Fibrous Cement	120m <sup>2</sup>	NAD
