# COMPLIANCE ASBESTOS RE-INSPECTION AND RISK ASSESSMENT

NOVEMBER 2021

J033465

ROCKHAMPTON NORTH CAMPUS\_RES Building 042 - Byerley House  
Bruce Highway  
ROCKHAMPTON NORTH QLD  
4700

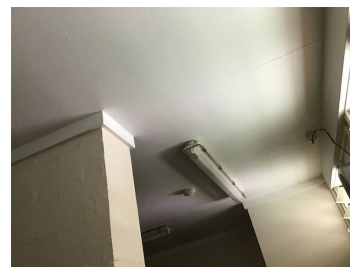
| Item Number | 7 | Material Score | 3 | Disturbance Score | 1 |

| Location | | 042 Byerley House - 1st Floor - Unisex Bathroom West - Throughout shower & toilet - Ceiling - Fibre cement sheet | | | |
| Sample No. | As 1-686 {AO000192} | Extent of damage | 0 | Disturbance | 1 |
| | | Priority Score | 4 | Very Low | |

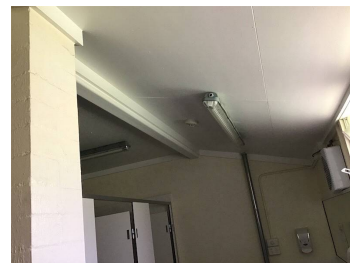
| Item Number | 8 | Material Score | 3 | Disturbance Score | 1 |

| Location | | 042 Byerley House - 1st Floor - East Kitchen - Throughout - Ceiling - Fibre cement sheet | | | |
| Sample No. | As 1-686 {AO000192} | Extent of damage | 0 | Disturbance | 1 |
| | | Priority Score | 4 | Very Low | |
