COMPLIANCE ASBESTOS RE-INSPECTION AND RISK ASSESSMENT

NOVEMBER 2021

J033466

ROCKHAMPTON NORTH CAMPUS_RES Building 043 - Pillbeam Hall
Bruce Highway
ROCKHAMPTON NORTH QLD
4700

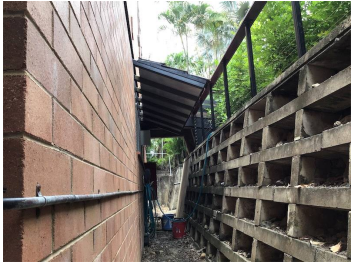
Location	043 Pillbeam Hall - Basement - External - South, East & West elevations - Sunshade ceiling

Hazard Type	Asbestos	Material Assessment		Disturbance Assessment	
Friability	Non-friable	Product Type	1	Occupancy	0
Sample No.	1-673 {AO000193}	Extent of damage	0	Disturbance	1
Result	Positive Chrysotile	Surface Treatment	1	Exposure	0
		Asbestos Type	1	Maintenance	0
Item Number	1	Material Score	3	Disturbance Score	1
		Priority Score	4	Very Low

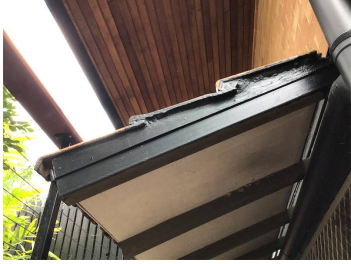
Location	043 Pillbeam Hall - Basement - External - Vertical edges to all sunshades - Sunshade edging - Fibre cement sheet

Hazard Type	Asbestos	Material Assessment		Disturbance Assessment	
Friability	Non-friable	Product Type	1	Occupancy	0
Sample No.	As 1-673 {AO000193}	Extent of damage	0	Disturbance	1
Result	Strongly Assumed Positive Chrysotile	Surface Treatment	1	Exposure	0
		Asbestos Type	1	Maintenance	0
Item Number	2	Material Score	3	Disturbance Score	1
		Priority Score	4	Very Low

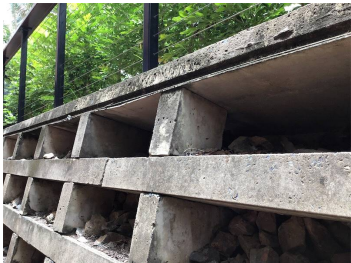
Location	043 Pillbeam Hall - Basement - External - East, South & West elevations - Retaining wall formwork - Fibre cement

Hazard Type	Asbestos	Material Assessment		Disturbance Assessment	
Friability	Non-friable	Product Type	1	Occupancy	0
Sample No.	1-674 {AO000194}	Extent of damage	1	Disturbance	1
Result	Positive Chrysotile	Surface Treatment	1	Exposure	0
		Asbestos Type	1	Maintenance	0
Item Number	3	Material Score	4	Disturbance Score	1
		Priority Score	5	Very Low

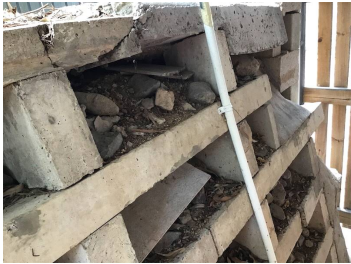
Location	043 Pillbeam Hall - Basement - External - West elevation - Formwork Debris - Fibre cement sheet

Hazard Type	Asbestos	Material Assessment		Disturbance Assessment	
Friability	Non-friable	Product Type	1	Occupancy	0
Sample No.	As 1-674 {AO000194}	Extent of damage	2	Disturbance	0
Result	Strongly Assumed Positive Chrysotile	Surface Treatment	2	Exposure	0
		Asbestos Type	1	Maintenance	0
Item Number	4	Material Score	6	Disturbance Score	0
		Priority Score	6	Very Low

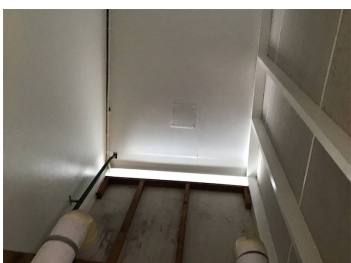
Location	043 Pillbeam Hall - Ground Floor - Gas Tank Storage - Throughout - Ceiling - Fibre cement sheet

Hazard Type	Asbestos	Material Assessment		Disturbance Assessment	
Friability	Non-friable	Product Type	1	Occupancy	0
Sample No.	Visual	Extent of damage	0	Disturbance	1
Result	Assumed Positive Unknown or Crocidolite	Surface Treatment	1	Exposure	0
		Asbestos Type	3	Maintenance	0
Item Number	11	Material Score	5	Disturbance Score	1
		Priority Score	6	Very Low

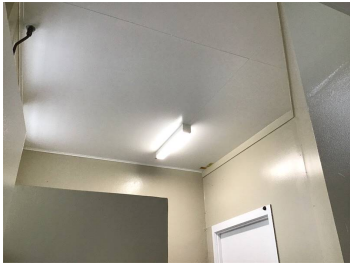
Location	043 Pillbeam Hall - Ground Floor - Shower Room (G.12) - Throughout - Ceiling - Fibre cement sheet

Hazard Type	Asbestos	Material Assessment		Disturbance Assessment	
Friability	Non-friable	Product Type	1	Occupancy	0
Sample No.	1-664 {AO000195}	Extent of damage	0	Disturbance	1
Result	Positive Chrysotile	Surface Treatment	1	Exposure	0
		Asbestos Type	1	Maintenance	0
Item Number	7	Material Score	3	Disturbance Score	1
		Priority Score	4	Very Low

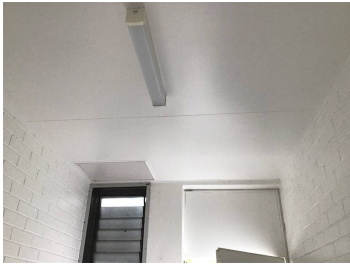
Location	043 Pillbeam Hall - Ground Floor - Disabled Bathroom - Throughout - Ceiling - Fibre cement sheet

Hazard Type	Asbestos	Material Assessment		Disturbance Assessment	
Friability	Non-friable	Product Type	1	Occupancy	0
Sample No.	As 1-664 {AO000195}	Extent of damage	0	Disturbance	1
Result	Strongly Assumed Positive Chrysotile	Surface Treatment	1	Exposure	0
		Asbestos Type	1	Maintenance	0
Item Number	8	Material Score	3	Disturbance Score	1
		Priority Score	4	Very Low

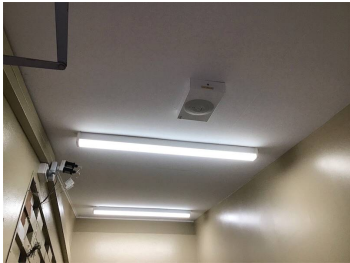
Location	043 Pillbeam Hall - Ground Floor - Male Bathroom (G.T08) - Throughout - Ceiling - Fibre cement sheet

Hazard Type	Asbestos	Material Assessment		Disturbance Assessment	
Friability	Non-friable	Product Type	1	Occupancy	0
Sample No.	As 1-664 {AO000195}	Extent of damage	0	Disturbance	1
Result	Strongly Assumed Positive Chrysotile	Surface Treatment	1	Exposure	0
		Asbestos Type	1	Maintenance	0
Item Number	9	Material Score	3	Disturbance Score	1
		Priority Score	4	Very Low

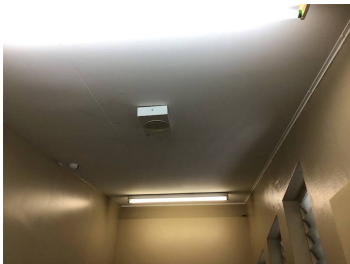
Location	043 Pillbeam Hall - Ground Floor - Female Bathroom (G.T09) - Throughout - Ceiling - Fibre cement sheet

Hazard Type	Asbestos	Material Assessment		Disturbance Assessment	
Friability	Non-friable	Product Type	1	Occupancy	0
Sample No.	As 1-664 {AO000195}	Extent of damage	0	Disturbance	1
Result	Strongly Assumed Positive Chrysotile	Surface Treatment	1	Exposure	0
		Asbestos Type	1	Maintenance	0
Item Number	10	Material Score	3	Disturbance Score	1
		Priority Score	4	Very Low

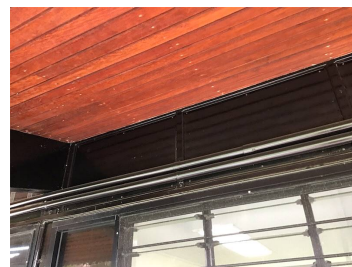
Location		043 Pillbeam Hall - Ground Floor - External - East elevation - above windows and doors - Infill panels - Fibre cement sheet			
Hazard Type	Asbestos	Material Assessment		Disturbance Assessment	
Friability	Non-friable	Product Type	1	Occupancy	0
Sample No.	1-677 {AO000196}	Extent of damage	0	Disturbance	1
Result	Positive Chrysotile	Surface Treatment	1	Exposure	0
		Asbestos Type	1	Maintenance	0
Item Number	14	Material Score	3	Disturbance Score	1
		Priority Score	4	Very Low
