ASBESTOS CONTAINING MATERIALS SURVEY REPORT

Cap College Workshop (Residential Precinct)
Building 044
Rockhampton North

Report Number 622.10968.00000/0040-R01-ASR-Blg044

27 December 2017

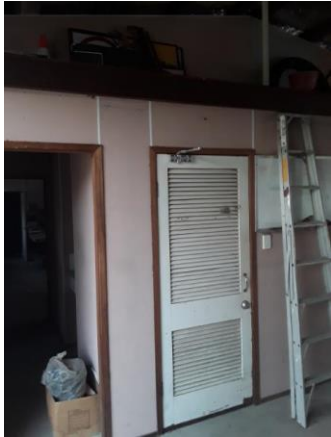
Sample No./ Visual Observation	Photo	Location			Analysis
		Int / Ext Floor Specific Location	Material Application	Extent	Result
1-310

Ground Floor all dividing walls	Internal wall, Fibrous Cement	1m ²	NAD
