COMPLIANCE ASBESTOS RE-INSPECTION AND RISK ASSESSMENT

NOVEMBER 2021

J033467

ROCKHAMPTON NORTH CAMPUS_RES Building 045 - Swanson Court - Block 4
Bruce Highway
ROCKHAMPTON NORTH QLD
4700

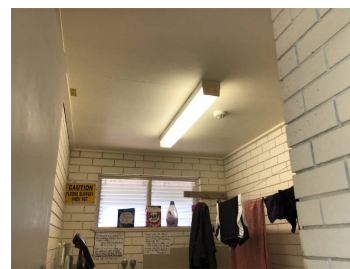
Location		045 Swanson Block 4 - Ground Floor - Laundry - Throughout - Ceiling - Fibre cement sheet					
Hazard Type		Asbestos		Material Assessment		Disturbance Assessment	
Friability		Non-friable		Product Type		1	
Sample No.		As 1-536 (AO000189)		Extent of damage		0	
Result		Strongly Assumed Positive Chrysotile		Surface Treatment		1	
				Asbestos Type		1	
Item Number		6		Material Score		3	
				Priority Score		4	
				Very Low

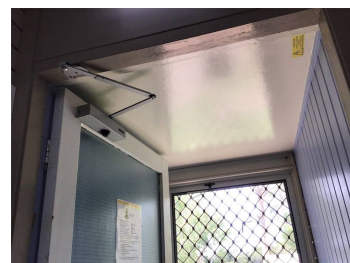
Location		045 Swanson Block 4 - Ground Floor - Entry Points - Northern & Southern - Ceiling - Fibre cement sheet			
Hazard Type		Asbestos		Material Assessment	Disturbance Assessment
Friability		Non-friable		Product Type	1
Sample No.		1-538 {AO000190}		Occupancy	0
Result		Positive Chrysotile		Extent of damage	0
				Disturbance	1
				Surface Treatment	1
Item Number		8		Exposure	0
				Asbestos Type	1
				Maintenance	0
				Material Score	3
				Disturbance Score	1
				Priority Score	4
				Very Low
