# COMPLIANCE ASBESTOS RE-INSPECTION AND RISK ASSESSMENT

NOVEMBER 2021

J033468

ROCKHAMPTON NORTH CAMPUS\_RES Building 046 - Swanson Court - Block 5  
Bruce Highway  
ROCKHAMPTON NORTH QLD  
4700

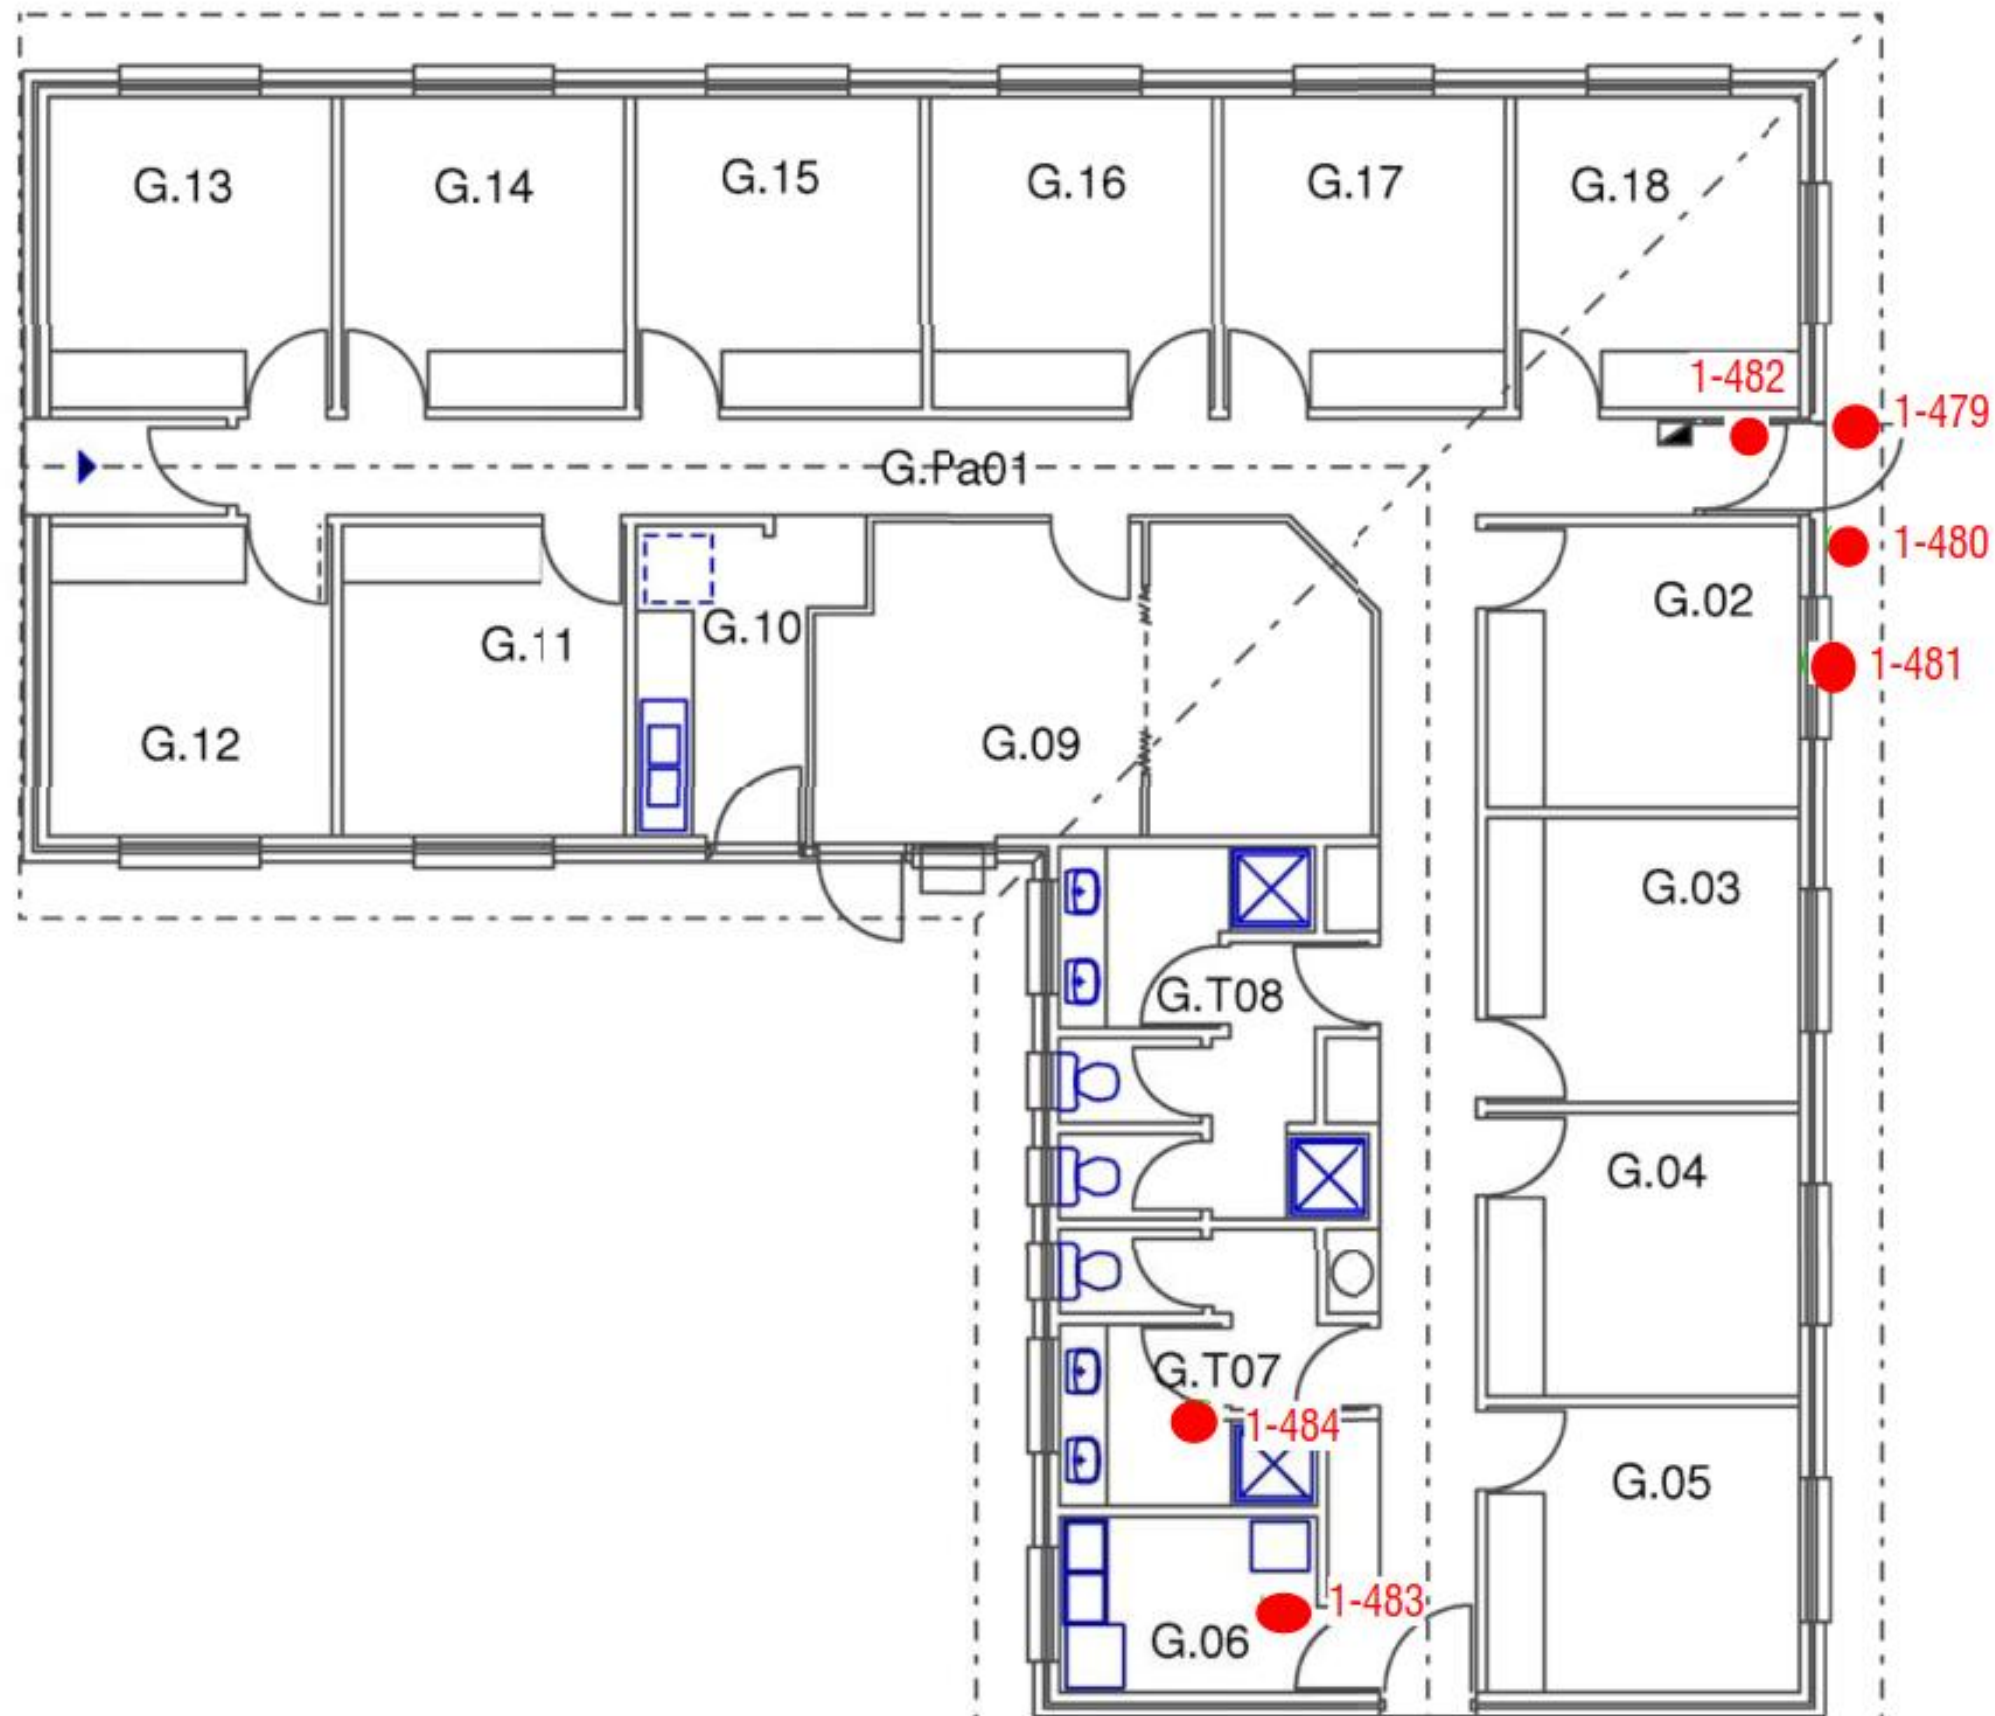
AREA: Swanson 046 - Ground Level

- Sample location  
No Asbestos Detected
- Sample location  
Asbestos Detected
