COMPLIANCE ASBESTOS RE-INSPECTION AND RISK ASSESSMENT

NOVEMBER 2021

J033469

ROCKHAMPTON NORTH CAMPUS_RES Building 047 - Swanson Court - Block 6
Bruce Highway
ROCKHAMPTON NORTH QLD
4700

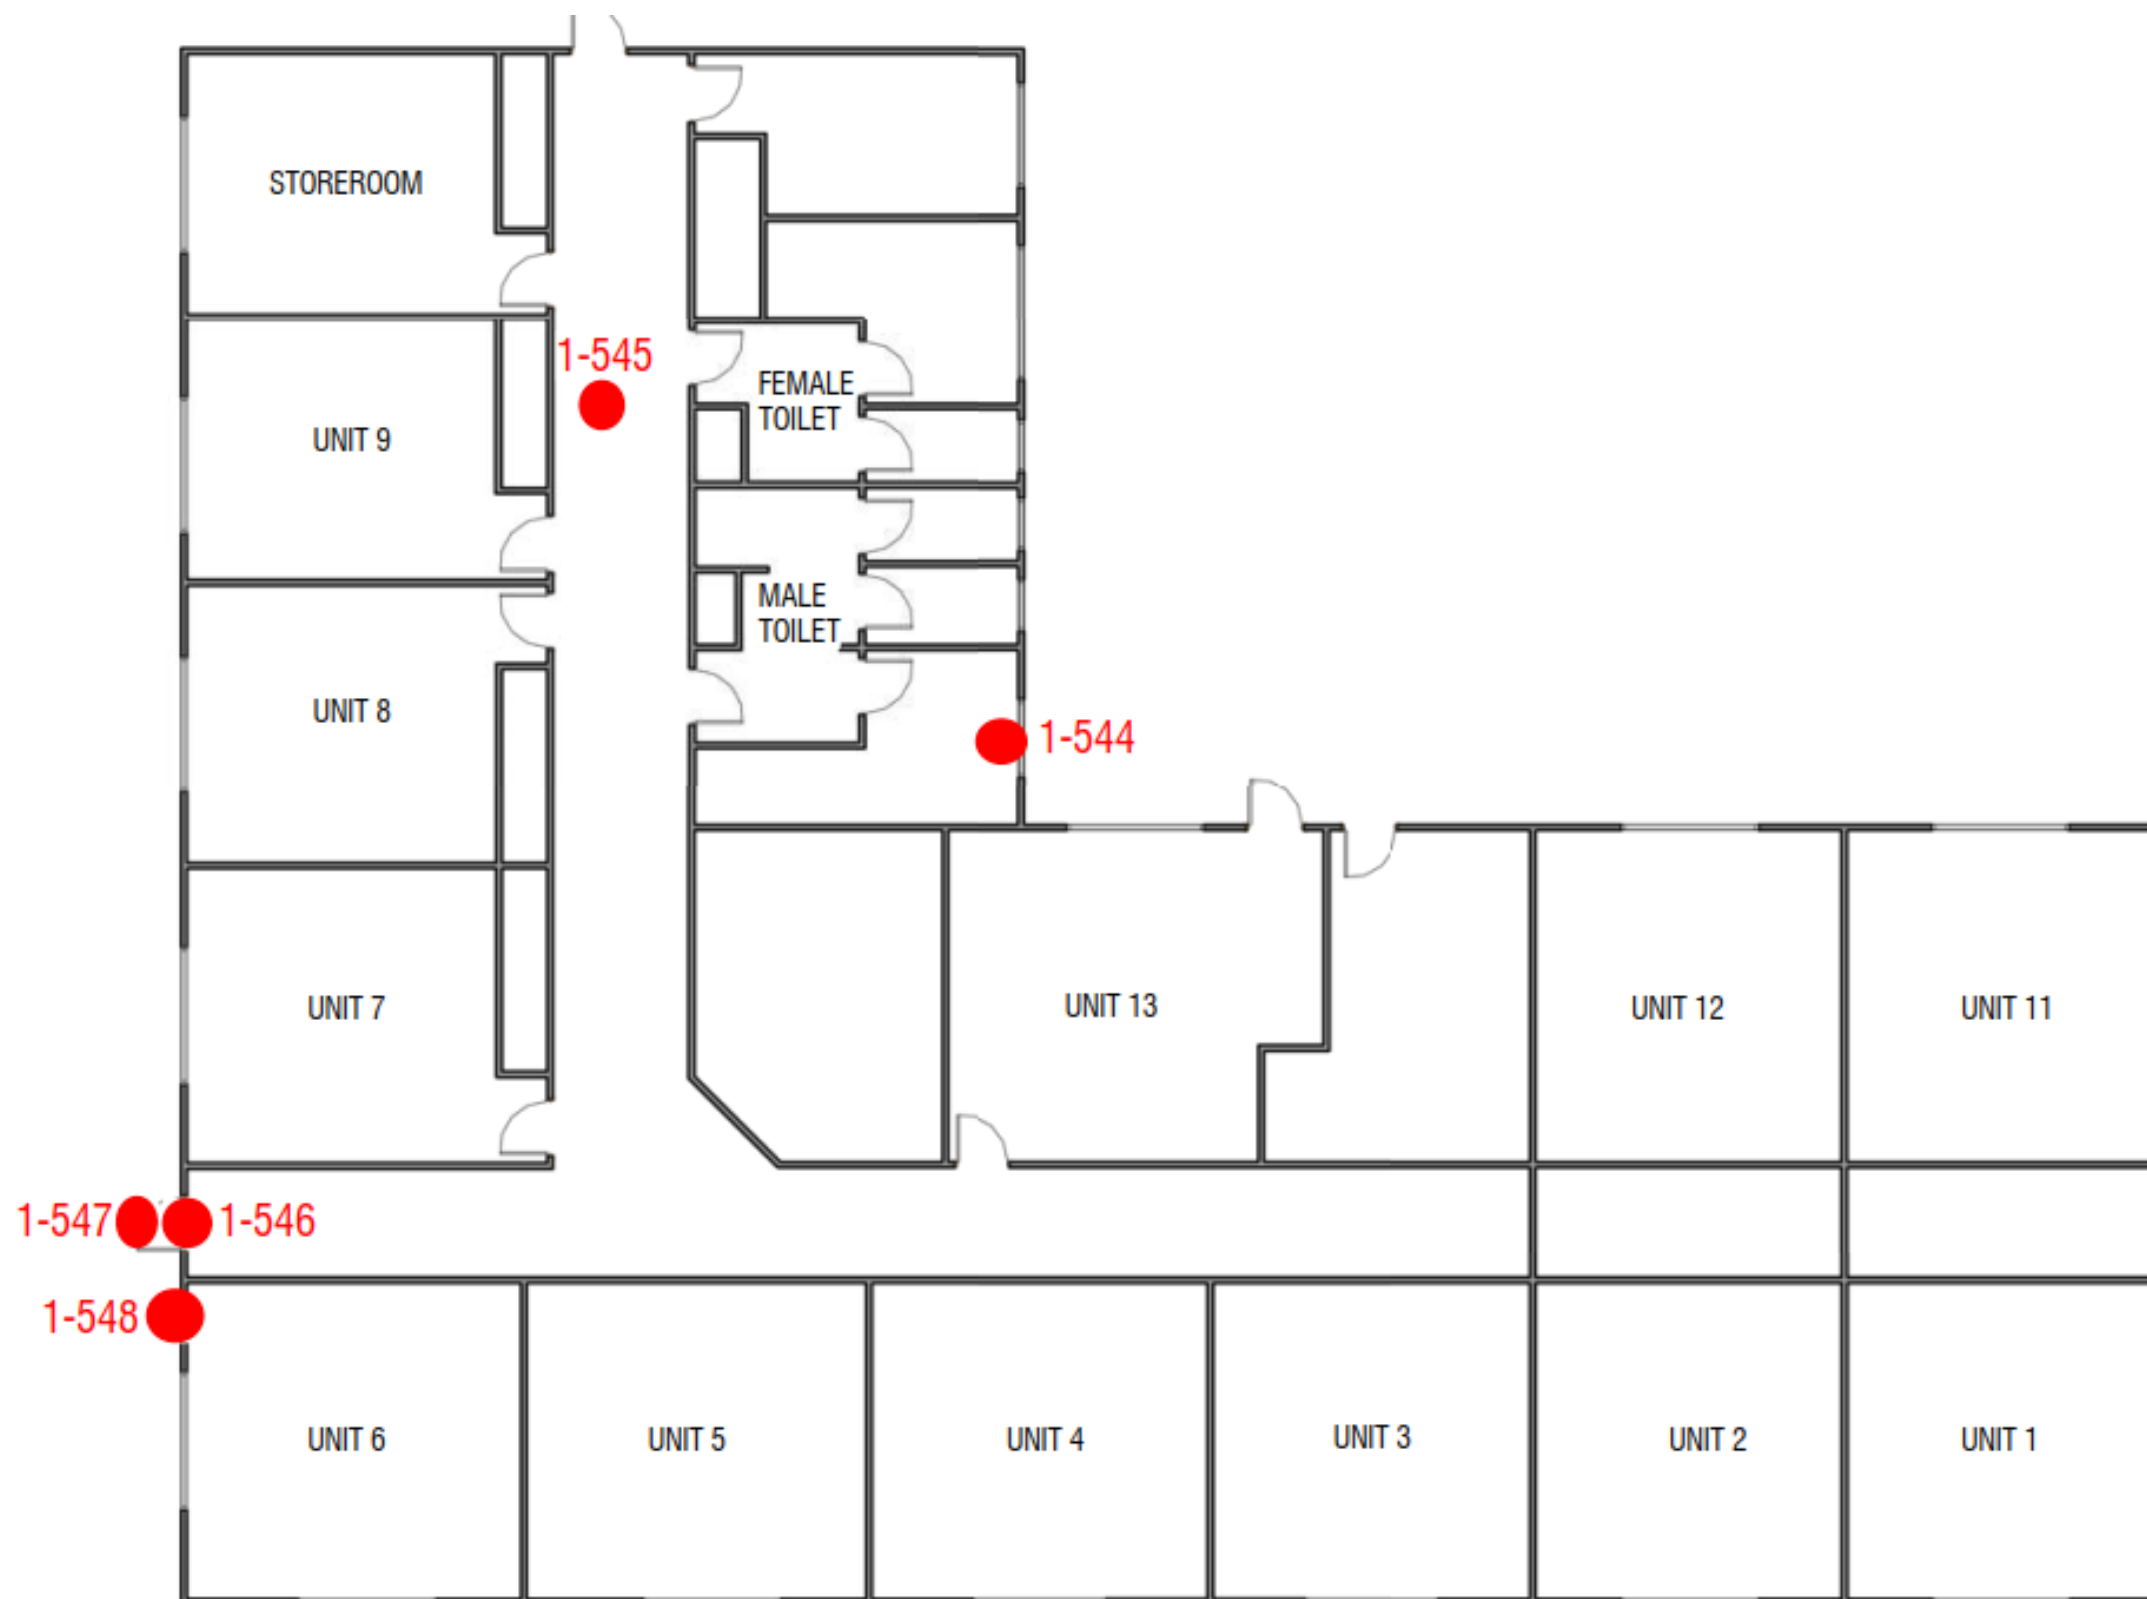
AREA: Swanson 047 – Ground Level

| Item No | Location / Description | Hazard Type | Sample No. | Item Status | Est. Extent | Current Label | Condition | Friability | Disturbance Risk | Material Risk | Control Priority | Recommended Action | Record of Works |
|---|--|---|---|---|---|---|---|---|---|---|---|---|---|
| | Soffits -Fibre cement sheet | Asbestos | 1-548 {AO000202} | Identified, Positive | 60m ² | No | Good Condition | Non-friable | Very Low | Very Low | P4 | Manage In Situ | |
| | Infill panels -Fibre cement sheet | Asbestos | 1-547 {AO000203} | Identified, Positive | 16m | No | Good Condition | Non-friable | Very Low | Very Low | P4 | Manage In Situ | |
| | Ceiling -Fibre cement sheet | Asbestos | 1-546 {AO000204} | Identified, Positive | 4m ² | No | Good Condition | Non-friable | Very Low | Very Low | P4 | Manage In Situ | |
| | Ceiling access packers -Fibre cement sheet | Asbestos | 1-545 {AO000206} | Identified, Positive | 2no. | No | Good Condition | Non-friable | Very Low | Very Low | P4 | Manage In Situ | |
