COMPLIANCE ASBESTOS RE-INSPECTION AND RISK ASSESSMENT

NOVEMBER 2021

J033470

ROCKHAMPTON NORTH CAMPUS_RES Building 048 - Ballard House
Bruce Highway
ROCKHAMPTON NORTH QLD
4700

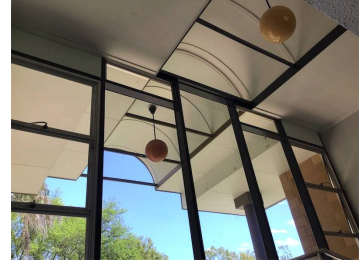
Location		048 Ballard House - Ground Floor - Foyer (1.Pa01) - North elevation - West & East sectionsInfill panels - Fibre cement sheet			
Hazard Type	Asbestos	Material Assessment		Disturbance Assessment	
Friability	Non-friable	Product Type	1	Occupancy	0
Sample No.	Visual	Extent of damage	0	Disturbance	1
Result	Assumed Positive Unknown or Crocidolite	Surface Treatment	1	Exposure	0
		Asbestos Type	3	Maintenance	0
Item Number	1	Material Score	5	Disturbance Score	1
		Priority Score	6	Very Low

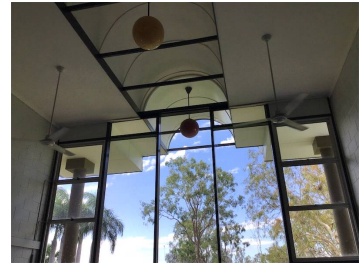
Location		048 Ballard House - Ground Floor - Foyer (1.Pa01) - South elevation - West & East sectionsInfill panels - Fibre cement sheet			
Hazard Type	Asbestos	Material Assessment		Disturbance Assessment	
Friability	Non-friable	Product Type	1	Occupancy	0
Sample No.	Visual	Extent of damage	0	Disturbance	1
Result	Assumed Positive Unknown or Crocidolite	Surface Treatment	1	Exposure	0
		Asbestos Type	3	Maintenance	0
Item Number	2	Material Score	5	Disturbance Score	1
		Priority Score	6	Very Low

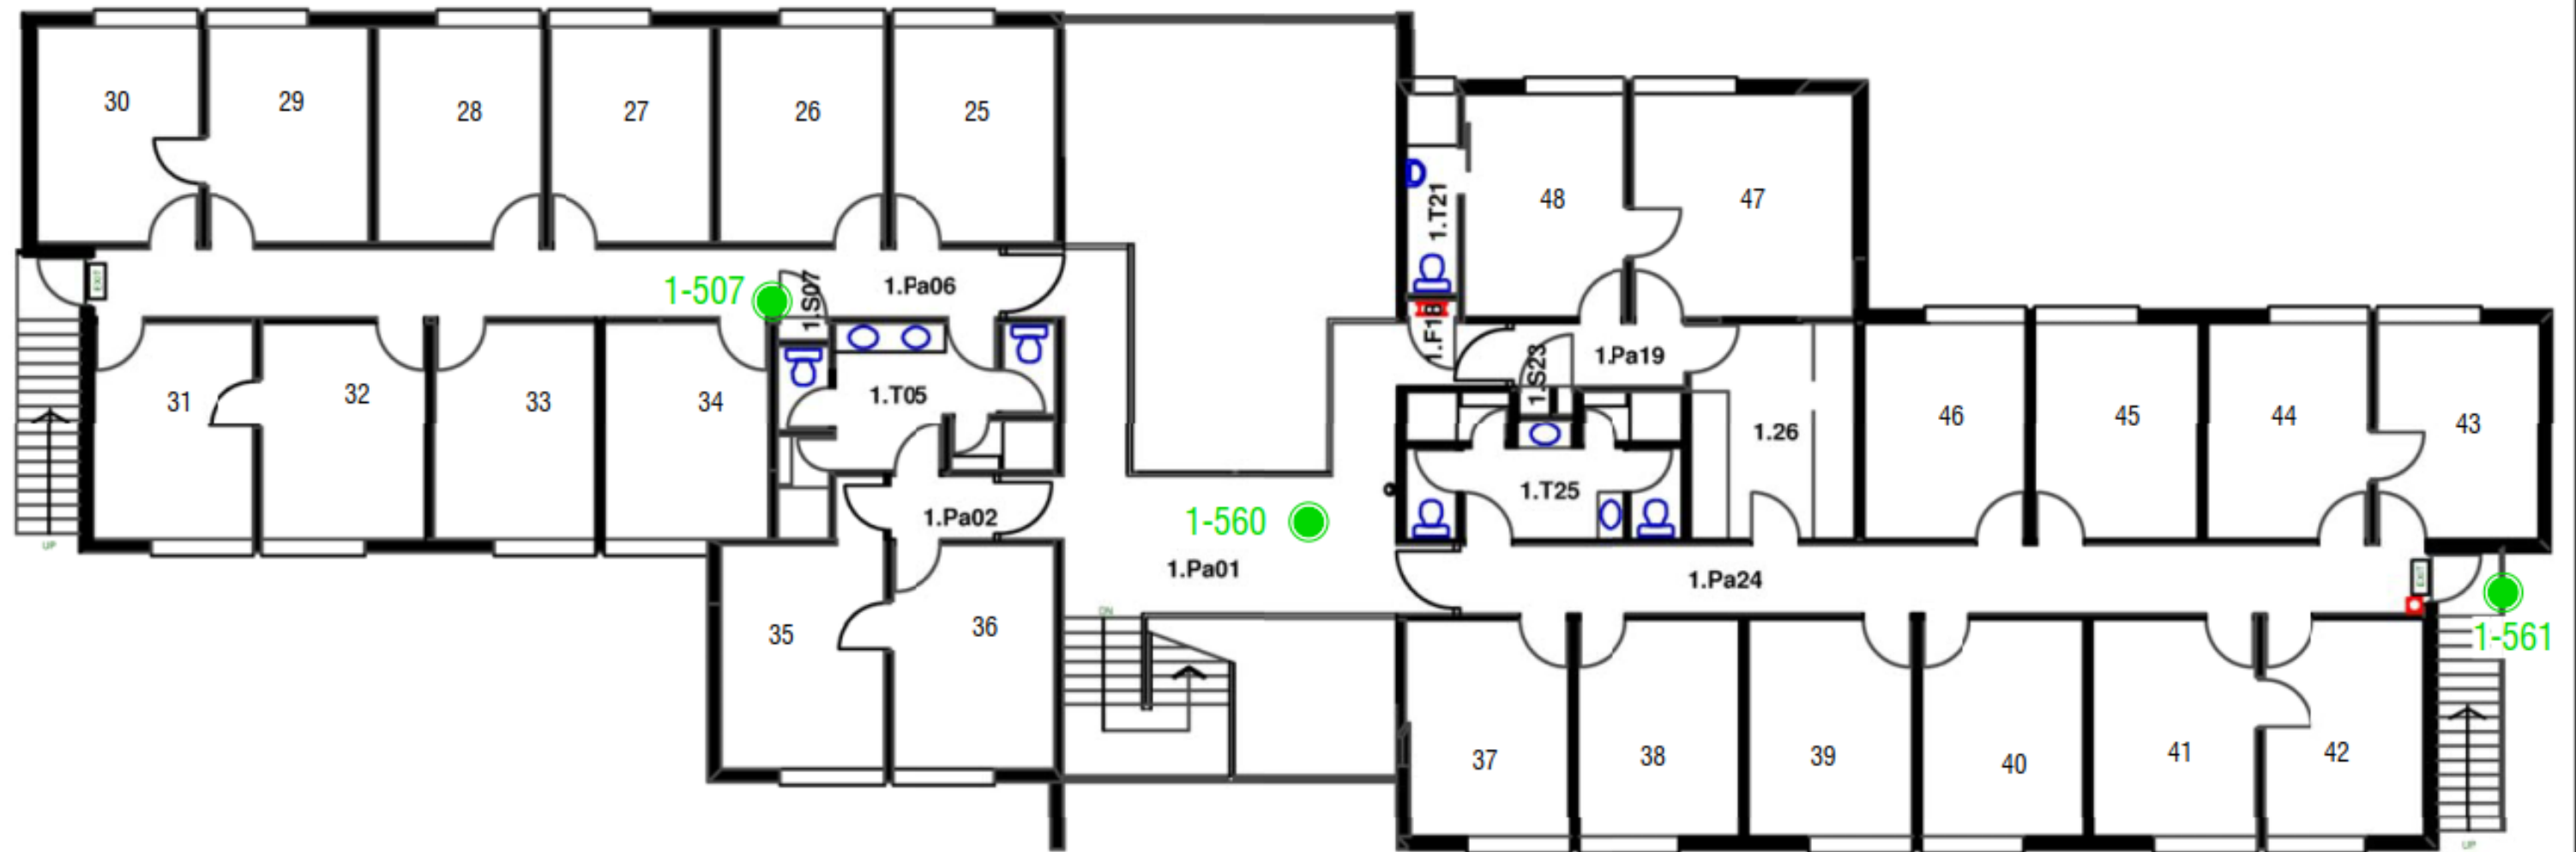
AREA: Ballard 048 – First Level

Assumed Asbestos
1st Floor WESTERN AND EASTERN ELEVATIONS. LEVEL 1
INFILL PANELS TO 1.Pa01
