COMPLIANCE ASBESTOS RE-INSPECTION AND RISK ASSESSMENT

NOVEMBER 2021

J033472

ROCKHAMPTON NORTH CAMPUS_RES Building 050 - Swanson Court - Block 2
Bruce Highway
ROCKHAMPTON NORTH QLD
4700

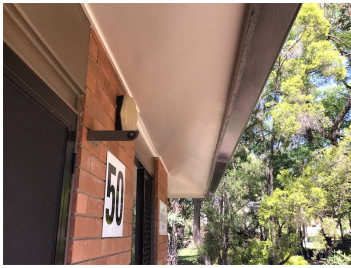
Location	050 Swanson Block 2 - Ground Floor - External - All elevations - Soffits - Fibre cement sheet

Hazard Type	Asbestos	Material Assessment	Disturbance Assessment	
Friability	Non-friable	Product Type	1	
Sample No.	1-486 (AO000207)	Extent of damage	0	
Result	Positive Chrysotile	Surface Treatment	1	
		Asbestos Type	1	
Item Number	1	Material Score	3	
		Priority Score	4	Very Low

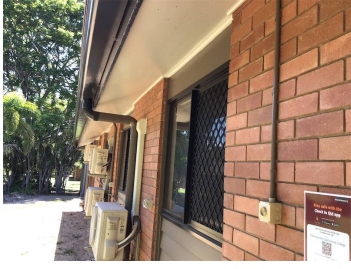
Location	050 Swanson Block 2 - Ground Floor - External - All elevations - above windows & doors - Infill panels - Fibre cement sheet

Hazard Type	Asbestos	Material Assessment	Disturbance Assessment	
Friability	Non-friable	Product Type	1	
Sample No.	1-485 (AO000208)	Extent of damage	0	
Result	Positive Chrysotile	Surface Treatment	1	
		Asbestos Type	1	
Item Number	2	Material Score	3	
		Priority Score	4	Very Low
