## ASBESTOS CONTAINING MATERIALS SURVEY REPORT

Gutekunst House (Residential Precinct)  
Building 053  
Rockhampton North

Report Number 622.10968.00000/0040-R01-ASR-Bld53

01 December 2017

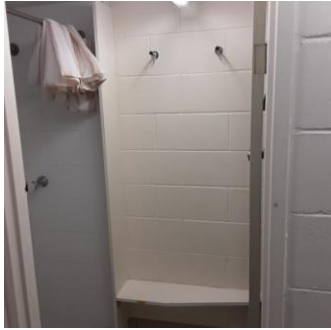
Ground Floor MALE ABLUTIONS/ SHOWER ROOM ( EASTERN SIDE OF GP.A01)	Vertical shower jam and adjoining shower seat, Fibrous Cement	1m <sup>2</sup>	NAD
Similar to 1-613

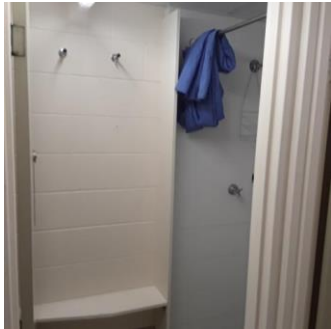
Ground Floor FEMALE ABLUTIONS/ SHOWER ROOM ( Western SIDE OF GP.A01)	Vertical shower jam and adjoining shower seat, Fibrous Cement	1m <sup>2</sup>	NAD

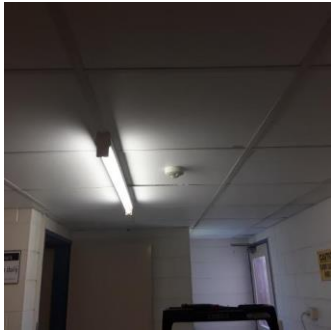
Ground Floor LAUNDRY ( SOUTHERN NORTHERN SIDE OF GPA01)	Ceiling tiles , Fibrous Cement	18m <sup>2</sup>	NAD
1-615

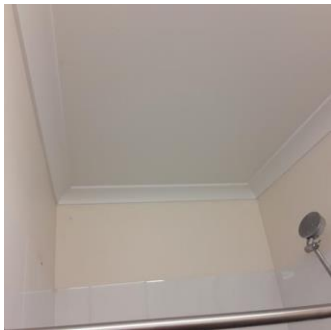
1st Floor FEMALE ABLUTIONS/ SHOWER ROOM ( WESTERN SIDE OF LEVEL 1 FOYER )	Wall sheeting. east,south and northern elevations , Fibrous Cement	12m <sup>2</sup>	NAD

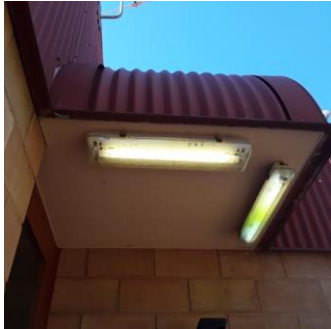
Ground Floor EXTERNAL	Level 1 open stairwell ceiling linings ( west and east elevations ), Fibrous Cement	2no	NAD

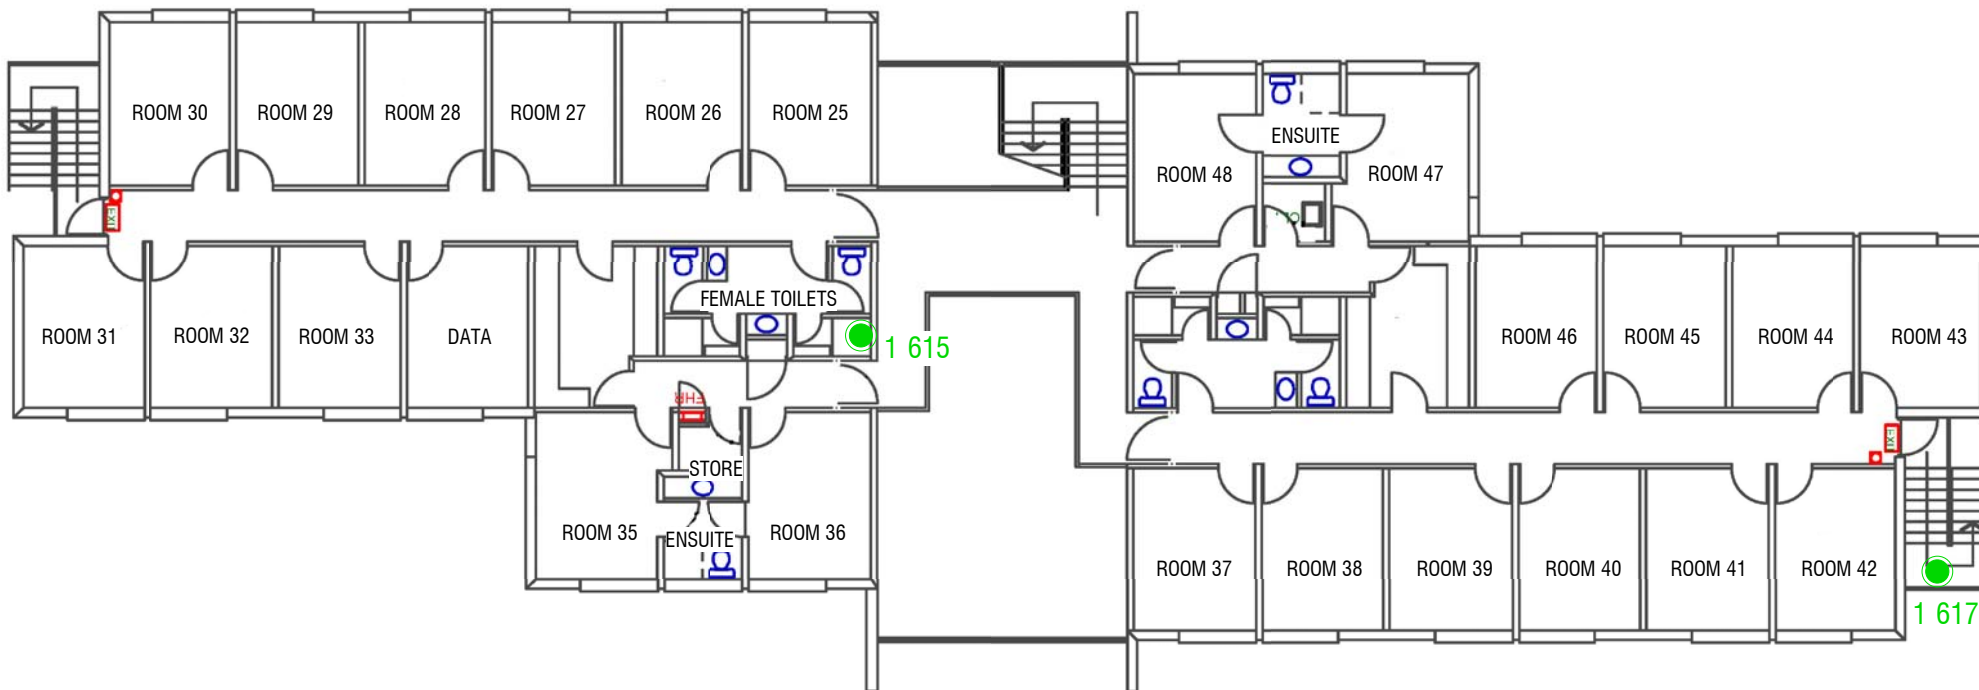
**Gutekunst House - Ground Level (Residential)**  
**Bruce Highway, Rockhampton North,**  
**QLD 4702**

Soffits are assumed to contain asbestos
