# COMPLIANCE ASBESTOS RE-INSPECTION AND RISK ASSESSMENT

NOVEMBER 2021

J033474

ROCKHAMPTON NORTH CAMPUS\_RES Building 055 - McCall House  
Bruce Highway  
ROCKHAMPTON NORTH QLD  
4700

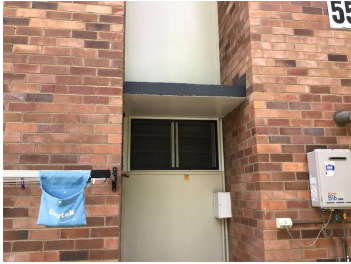
Location	055 McCall House - Ground Floor - External - West elevation - Infill panel - Fibre cement sheet

Hazard Type	Asbestos	Material Assessment	Disturbance Assessment		
Friability	Non-friable	Product Type	1	Occupancy	0
Sample No.	1-663 (AO000227)	Extent of damage	0	Disturbance	1
Result	Positive Chrysotile	Surface Treatment	1	Exposure	0
		Asbestos Type	1	Maintenance	0
Item Number	3	Material Score	3	Disturbance Score	1
		Priority Score	4	Very Low

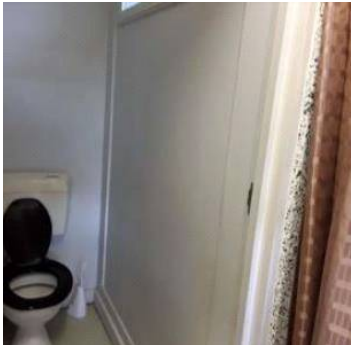
Location	055 McCall House - Ground Floor - MCOO Room - Toilet - West elevation - Wall - Fibre cement sheet

Hazard Type	Asbestos	Material Assessment	Disturbance Assessment		
Friability	Non-friable	Product Type	1	Occupancy	0
Sample No.	1-658 (AO000226)	Extent of damage	0	Disturbance	1
Result	Positive Chrysotile	Surface Treatment	1	Exposure	0
		Asbestos Type	1	Maintenance	0
Item Number	15	Material Score	3	Disturbance Score	1
		Priority Score	4	Very Low

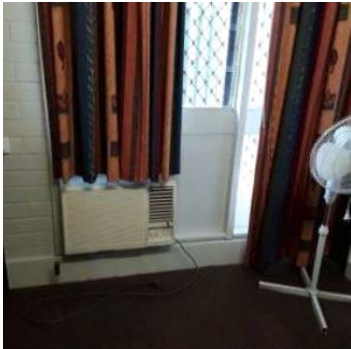
Location	055 McCall House - Ground Floor - MCOO Room - Above doorway & around AC unit - Infill panel - Fibre cement sheet

Hazard Type	Asbestos	Material Assessment	Disturbance Assessment		
Friability	Non-friable	Product Type	1	Occupancy	0
Sample No.	As 1-658 (AO000226)	Extent of damage	0	Disturbance	1
Result	Strongly Assumed Positive Chrysotile	Surface Treatment	1	Exposure	0
		Asbestos Type	1	Maintenance	0
Item Number	16	Material Score	3	Disturbance Score	1
		Priority Score	4	Very Low

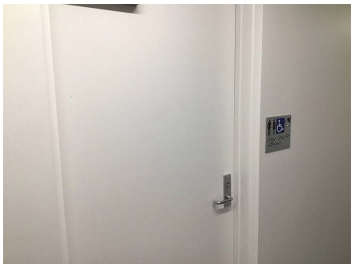
Location	055 McCall House - Ground Floor - Female Toilet - Throughout - Ceiling - Fibre cement sheet

Hazard Type	Asbestos	Material Assessment	Disturbance Assessment		
Friability	Non-friable	Product Type	1	Occupancy	0
Sample No.	As 1-663 (AO000227)	Extent of damage	0	Disturbance	1
Result	Strongly Assumed Positive Chrysotile	Surface Treatment	1	Exposure	0
		Asbestos Type	1	Maintenance	0
Item Number	18	Material Score	3	Disturbance Score	1
		Priority Score	4	Very Low

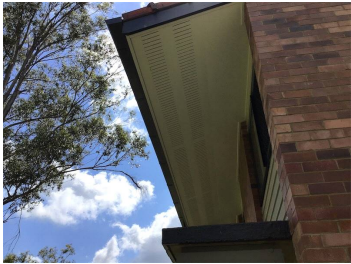
Location	055 McCall House - 1st Floor - External - All elevations - Soffits - Fibre cement sheet

Hazard Type	Asbestos	Material Assessment	Disturbance Assessment		
Friability	Non-friable	Product Type	1	Occupancy	0
Sample No.	Visual	Extent of damage	0	Disturbance	1
Result	Assumed Positive Unknown or Crocidolite	Surface Treatment	1	Exposure	0
		Asbestos Type	3	Maintenance	0
Item Number	1	Material Score	5	Disturbance Score	1
		Priority Score	6	Very Low

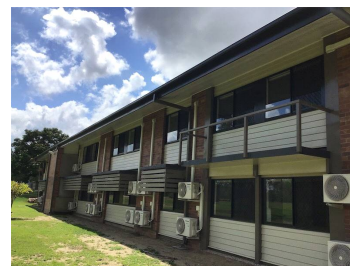
Location		055 McCall House - 1st Floor - External - East & West elevations - above windows - Fascia - Fibre cement sheet			
Hazard Type	Asbestos	Material Assessment		Disturbance Assessment	
Friability	Non-friable	Product Type	1	Occupancy	0
Sample No.	Visual	Extent of damage	0	Disturbance	1
Result	Assumed Positive Unknown or Crocidolite	Surface Treatment	1	Exposure	0
		Asbestos Type	3	Maintenance	0
Item Number	2	Material Score	5	Disturbance Score	1
		Priority Score	6	Very Low

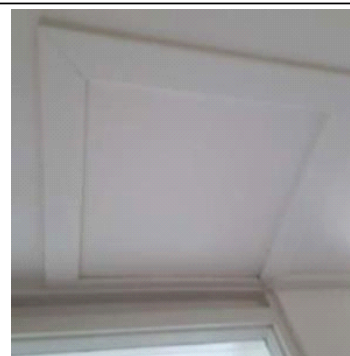
Location		055 McCall House - 1st Floor - MCFL Room - Throughout - Ceiling - Fibre cement sheet			
Hazard Type	Asbestos	Material Assessment		Disturbance Assessment	
Friability	Non-friable	Product Type	1	Occupancy	0
Sample No.	As 1-653 {AO000223}	Extent of damage	0	Disturbance	1
Result	Strongly Assumed Positive Chrysotile	Surface Treatment	1	Exposure	0
		Asbestos Type	1	Maintenance	0
Item Number	12	Material Score	3	Disturbance Score	1
		Priority Score	4	Very Low

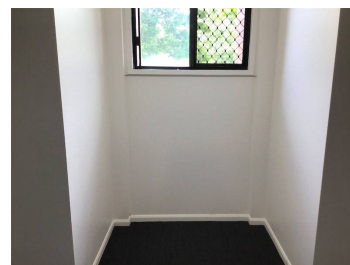
Location		055 McCall House - 1st Floor - Corridor - East elevation - below window - Infill panel - Fibre cement sheet			
Hazard Type	Asbestos	Material Assessment		Disturbance Assessment	
Friability	Non-friable	Product Type	1	Occupancy	0
Sample No.	1-655 {AO000224}	Extent of damage	0	Disturbance	1
Result	Positive Chrysotile	Surface Treatment	1	Exposure	0
		Asbestos Type	1	Maintenance	0
Item Number	13	Material Score	3	Disturbance Score	1
		Priority Score	4	Very Low

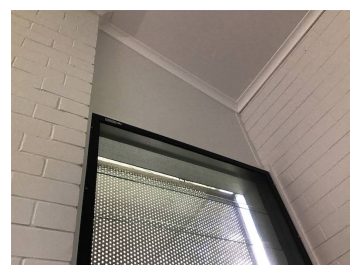
Location		055 McCall House - 1st Floor - Stairwells - Above windows - East & West stairwells - Infill panels - Fibre cement sheet			
Hazard Type	Asbestos	Material Assessment		Disturbance Assessment	
Friability	Non-friable	Product Type	1	Occupancy	0
Sample No.	1-656 {AO000225}	Extent of damage	0	Disturbance	1
Result	Positive Chrysotile	Surface Treatment	1	Exposure	0
		Asbestos Type	1	Maintenance	0
Item Number	14	Material Score	3	Disturbance Score	1
		Priority Score	4	Very Low

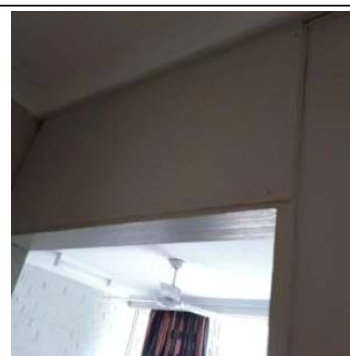
Location		055 McCall House - 1st Floor - Advisor Room - Above windows and doors - Infill panels - Fibre cement sheet			
Hazard Type	Asbestos	Material Assessment		Disturbance Assessment	
Friability	Non-friable	Product Type	1	Occupancy	0
Sample No.	As 1-658 {AO000226}	Extent of damage	0	Disturbance	1
Result	Strongly Assumed Positive Chrysotile	Surface Treatment	1	Exposure	0
		Asbestos Type	1	Maintenance	0
Item Number	17	Material Score	3	Disturbance Score	1
		Priority Score	4	Very Low
