# COMPLIANCE ASBESTOS RE-INSPECTION AND RISK ASSESSMENT

NOVEMBER 2021

J033476

ROCKHAMPTON NORTH CAMPUS\_RES Building 060 - Fitzroy Jardine House  
Bruce Highway  
ROCKHAMPTON NORTH QLD  
4700

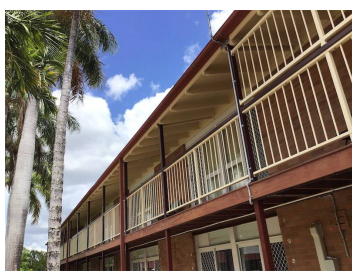
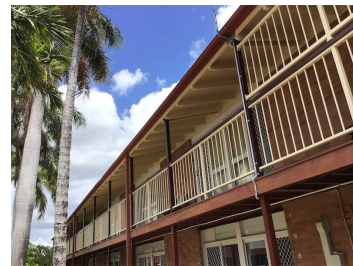
Location		060 Jardine House - 1st Floor - External - Balcony - North & South elevation - Ceiling - Fibre cement sheet					
Hazard Type		Asbestos		Material Assessment		Disturbance Assessment	
Friability		Non-friable		Product Type		1 Occupancy 0	
Sample No.		1-494 {AO000232}		Extent of damage		0 Disturbance 1	
Result		Positive Chrysotile		Surface Treatment		1 Exposure 0	
				Asbestos Type		1 Maintenance 0	
Item Number		1		Material Score		3 Disturbance Score 1	
				Priority Score		4 Very Low
