COMPLIANCE ASBESTOS RE-INSPECTION AND RISK ASSESSMENT

NOVEMBER 2021

J033477

ROCKHAMPTON NORTH CAMPUS_RES Building 061 - Jardine/Hopkins House Laundry
Bruce Highway
ROCKHAMPTON NORTH QLD
4700

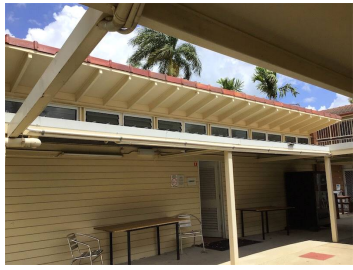
Location	061 Laundry - Ground Floor - External - East elevation - Soffit - Fibre cement sheet				
Hazard Type	Asbestos	Material Assessment		Disturbance Assessment	
Friability	Non-friable	Product Type	1	Occupancy	0
Sample No.	1-283 {AO000233}	Extent of damage	0	Disturbance	1
Result	Positive Chrysotile + Amosite	Surface Treatment	1	Exposure	0
		Asbestos Type	2	Maintenance	0
Item Number	1	Material Score	4	Disturbance Score	1
		Priority Score	5	Very Low

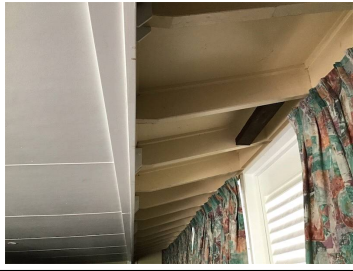
Location	061 Laundry - Ground Floor - Storage - East elevation - Internal soffit - Fibre cement sheet				
Hazard Type	Asbestos	Material Assessment		Disturbance Assessment	
Friability	Non-friable	Product Type	1	Occupancy	0
Sample No.	1-284 {AO000234}	Extent of damage	0	Disturbance	1
Result	Positive Chrysotile + Amosite	Surface Treatment	1	Exposure	0
		Asbestos Type	2	Maintenance	0
Item Number	2	Material Score	4	Disturbance Score	1
		Priority Score	5	Very Low
