COMPLIANCE ASBESTOS RE-INSPECTION AND RISK ASSESSMENT

NOVEMBER 2021

J033477

ROCKHAMPTON NORTH CAMPUS_RES Building 061 - Jardine/Hopkins House Laundry
Bruce Highway
ROCKHAMPTON NORTH QLD
4700

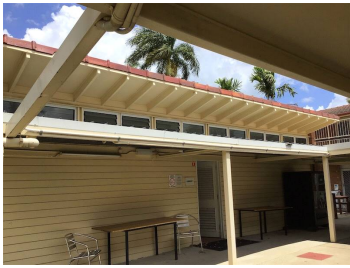
Location	061 Laundry - Ground Floor - External - East elevation - Soffit - Fibre cement sheet

Hazard Type	Asbestos	Material Assessment		Disturbance Assessment	
Friability	Non-friable	Product Type	1	Occupancy	0
Sample No.	1-283 {AO000233}	Extent of damage	0	Disturbance	1
Result	Positive Chrysotile + Amosite	Surface Treatment	1	Exposure	0
		Asbestos Type	2	Maintenance	0
Item Number	1	Material Score	4	Disturbance Score	1
		Priority Score	5	Very Low

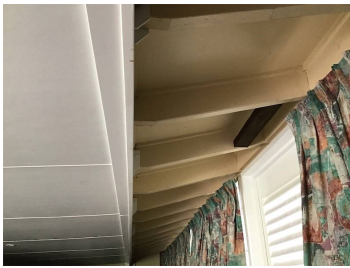
Location	061 Laundry - Ground Floor - Storage - East elevation - Internal soffit - Fibre cement sheet

Hazard Type	Asbestos	Material Assessment		Disturbance Assessment	
Friability	Non-friable	Product Type	1	Occupancy	0
Sample No.	1-284 {AO000234}	Extent of damage	0	Disturbance	1
Result	Positive Chrysotile + Amosite	Surface Treatment	1	Exposure	0
		Asbestos Type	2	Maintenance	0
Item Number	2	Material Score	4	Disturbance Score	1
		Priority Score	5	Very Low
