# COMPLIANCE ASBESTOS RE-INSPECTION AND RISK ASSESSMENT

NOVEMBER 2021

J033478

ROCKHAMPTON NORTH CAMPUS\_RES Building 062 - Beatrice Hutton House  
Bruce Highway  
ROCKHAMPTON NORTH QLD  
4700

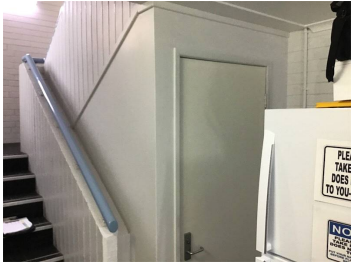
Location	062 Hopkins House - Ground Floor - Stairwell Storage - North elevation - External walls - Fibre cement sheet

Hazard Type	Asbestos	Material Assessment	Disturbance Assessment		
Friability	Non-friable	Product Type	1	Occupancy	0
Sample No.	As 1-702 {AO000235}	Extent of damage	0	Disturbance	1
Result	Strongly Assumed Positive Chrysotile	Surface Treatment	1	Exposure	0
		Asbestos Type	1	Maintenance	0
Item Number	6	Material Score	3	Disturbance Score	1
		Priority Score	4	Very Low

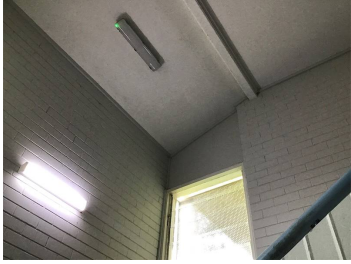
Location	062 Hopkins House - Ground Floor - Stairwells - Above windows to both Stairwells - In-fill panels - Fibre cement sheet

Hazard Type	Asbestos	Material Assessment	Disturbance Assessment		
Friability	Non-friable	Product Type	1	Occupancy	0
Sample No.	As 1-702 {AO000235}	Extent of damage	0	Disturbance	1
Result	Strongly Assumed Positive Chrysotile	Surface Treatment	1	Exposure	0
		Asbestos Type	1	Maintenance	0
Item Number	7	Material Score	3	Disturbance Score	1
		Priority Score	4	Very Low

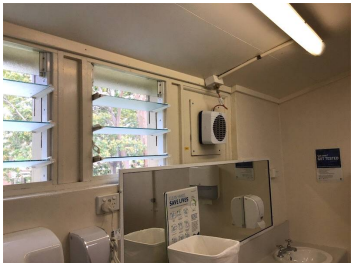
Location	062 Hopkins House - 1st Floor - Male Bathroom - East elevation - In-fill panel - Fibre cement sheet

Hazard Type	Asbestos	Material Assessment	Disturbance Assessment		
Friability	Non-friable	Product Type	1	Occupancy	0
Sample No.	1-702 {AO000235}	Extent of damage	0	Disturbance	1
Result	Positive Chrysotile	Surface Treatment	1	Exposure	0
		Asbestos Type	1	Maintenance	0
Item Number	1	Material Score	3	Disturbance Score	1
		Priority Score	4	Very Low

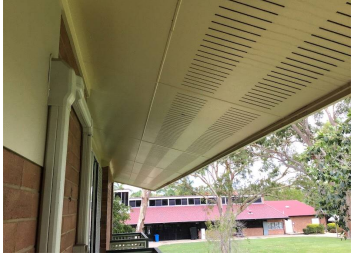
Location	062 Hopkins House - 1st Floor - External - All elevations - Soffits - Fibre cement sheet

Hazard Type	Asbestos	Material Assessment	Disturbance Assessment		
Friability	Non-friable	Product Type	1	Occupancy	0
Sample No.	1-700 {AO000236}	Extent of damage	0	Disturbance	1
Result	Positive Chrysotile	Surface Treatment	1	Exposure	0
		Asbestos Type	1	Maintenance	0
Item Number	2	Material Score	3	Disturbance Score	1
		Priority Score	4	Very Low

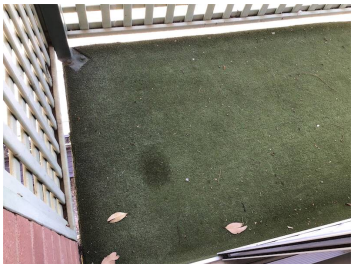
Location	062 Hopkins House - 1st Floor - External - Balcony - Under astro turf - North Eastern Room Floor - Fibre cement sheet

Hazard Type	Asbestos	Material Assessment	Disturbance Assessment		
Friability	Non-friable	Product Type	1	Occupancy	0
Sample No.	1-701 {AO000237}	Extent of damage	0	Disturbance	1
Result	Positive Chrysotile	Surface Treatment	1	Exposure	0
		Asbestos Type	1	Maintenance	0
Item Number	3	Material Score	3	Disturbance Score	1
		Priority Score	4	Very Low

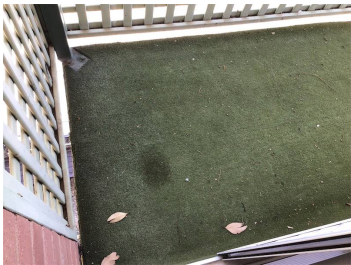
Location	062 Hopkins House - 1st Floor - External - Balcony - Under astro turf - North Eastern Room Floor waterproof membrane - Bituminous Lining

Hazard Type	Asbestos	Material Assessment		Disturbance Assessment	
Friability	Non-friable	Product Type	1	Occupancy	0
Sample No.	As 1-701 {AO000237}	Extent of damage	0	Disturbance	1
Result	Strongly Assumed Positive Chrysotile	Surface Treatment	1	Exposure	0
		Asbestos Type	1	Maintenance	0
Item Number	4	Material Score	3	Disturbance Score	1
		Priority Score	4	Very Low

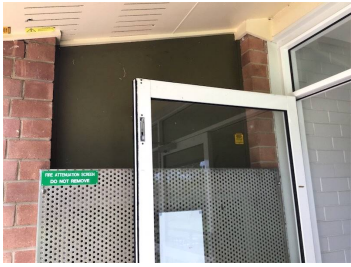
Location	062 Hopkins House - 1st Floor - External - North elevation - adj entrance doorway - Infill panel - Fibre cement sheet

Hazard Type	Asbestos	Material Assessment		Disturbance Assessment	
Friability	Non-friable	Product Type	1	Occupancy	0
Sample No.	As 1-702 {AO000235}	Extent of damage	0	Disturbance	1
Result	Strongly Assumed Positive Chrysotile	Surface Treatment	1	Exposure	0
		Asbestos Type	1	Maintenance	0
Item Number	8	Material Score	3	Disturbance Score	1
		Priority Score	4	Very Low

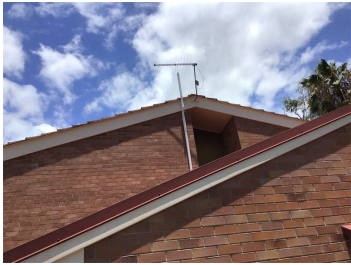
Location	062 Hopkins House - 1st Floor - External - East elevation - above window - Infill panel - Fibre cement sheet

Hazard Type	Asbestos	Material Assessment		Disturbance Assessment	
Friability	Non-friable	Product Type	1	Occupancy	0
Sample No.	As 1-702 {AO000235}	Extent of damage	0	Disturbance	1
Result	Strongly Assumed Positive Chrysotile	Surface Treatment	1	Exposure	0
		Asbestos Type	1	Maintenance	0
Item Number	9	Material Score	3	Disturbance Score	1
		Priority Score	4	Very Low

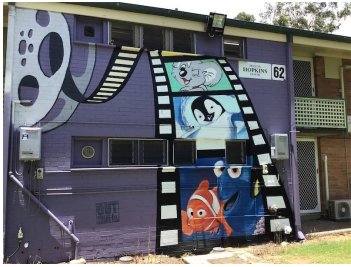
Location	062 Hopkins House - 1st Floor - External - North elevation - adj windows - Infill panel - Fibre cement sheet

Hazard Type	Asbestos	Material Assessment		Disturbance Assessment	
Friability	Non-friable	Product Type	1	Occupancy	0
Sample No.	As 1-702 {AO000235}	Extent of damage	0	Disturbance	1
Result	Strongly Assumed Positive Chrysotile	Surface Treatment	1	Exposure	0
		Asbestos Type	1	Maintenance	0
Item Number	10	Material Score	3	Disturbance Score	1
		Priority Score	4	Very Low

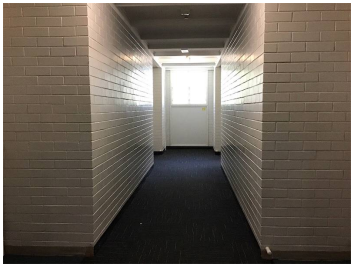
Location	062 Hopkins House - 1st Floor - Corridor - North elevation - Infill panel - Fibre cement sheet

Hazard Type	Asbestos	Material Assessment		Disturbance Assessment	
Friability	Non-friable	Product Type	1	Occupancy	0
Sample No.	As 1-702 {AO000235}	Extent of damage	0	Disturbance	1
Result	Strongly Assumed Positive Chrysotile	Surface Treatment	1	Exposure	0
		Asbestos Type	1	Maintenance	0
Item Number	5	Material Score	3	Disturbance Score	1
		Priority Score	4	Very Low
