**ASBESTOS CONTAINING MATERIALS
SURVEY REPORT**

**Spray Booth
Rockhampton City TAFE**

Report Number 622.10968.00000/0090-R01-ASR-SprayBooth

01 November 2017

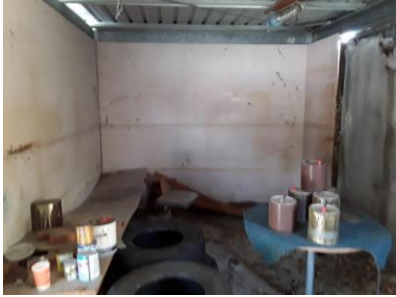
| Sample No./ Visual Observation | Photo | Location | | | Analysis |
|---|--|--|---|---|---|
| 3-937 | | 1st Floor INTERNAL WALL SHEETING - ALL ELEVATIONS | WALL SHEETING - ALL ELEVATIONS, Fibrous Cement | 28m ² | NAD |

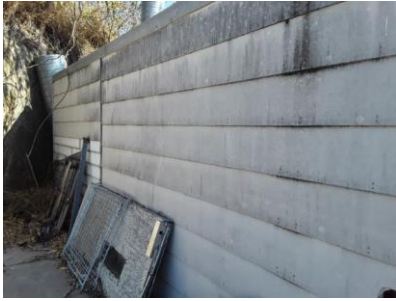
| Sample No./ Visual Observation | Photo | Location | | | Analysis |
|---|--|--|---|---|---|
| 3-936 | | 1st Floor EXTERNAL WALL SHEETING | WALL SHEETING - HARDIPLANK - SOUTH, EAST AND NORTH ELEVATION, Fibrous Cement | 24m ² | NAD |
