# COMPLIANCE ASBESTOS RE-INSPECTION AND RISK ASSESSMENT

NOVEMBER 2021

J033484

ROCKHAMPTON CITY CAMPUS\_Block E - Canning Street  
Canning Street  
ROCKHAMPTON QLD  
4700

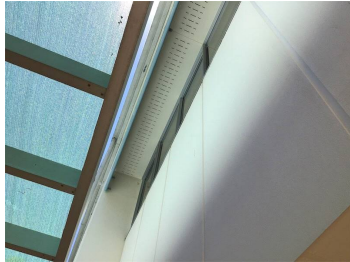
Location		Block E - 1st Floor - External - Soffit - Fibre cement sheet - North elevation - above windows

Hazard Type		Asbestos	Material Assessment		Disturbance Assessment		
Friability		Non-friable	Product Type	1	Occupancy		0
Sample No.		Visual	Extent of damage	0	Disturbance		1
Result		Assumed Positive Unknown or Crocidolite	Surface Treatment	1	Exposure		0
			Asbestos Type	3	Maintenance		0
Item Number		1	Material Score	5	Disturbance Score		1
			Priority Score	6	Very Low		
No Additional Photographic Evidence Available

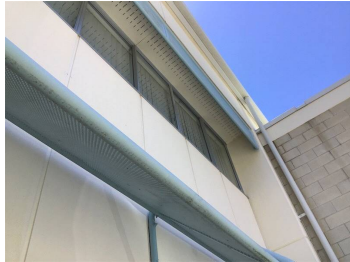
Location		Block E - 1st Floor - External - Soffit - Fibre cement sheet - South elevation - above windows

Hazard Type		Asbestos		Material Assessment			Disturbance Assessment					
Friability		Non-friable		Product Type			1		Occupancy		0	
Sample No.		Visual		Extent of damage			0		Disturbance		1	
Result		Assumed Positive Unknown or Crocidolite		Surface Treatment			1		Exposure		0	
				Asbestos Type			3		Maintenance		0	
Item Number		2		Material Score			5		Disturbance Score		1	
				Priority Score			6		Very Low			
No Additional Photographic Evidence Available

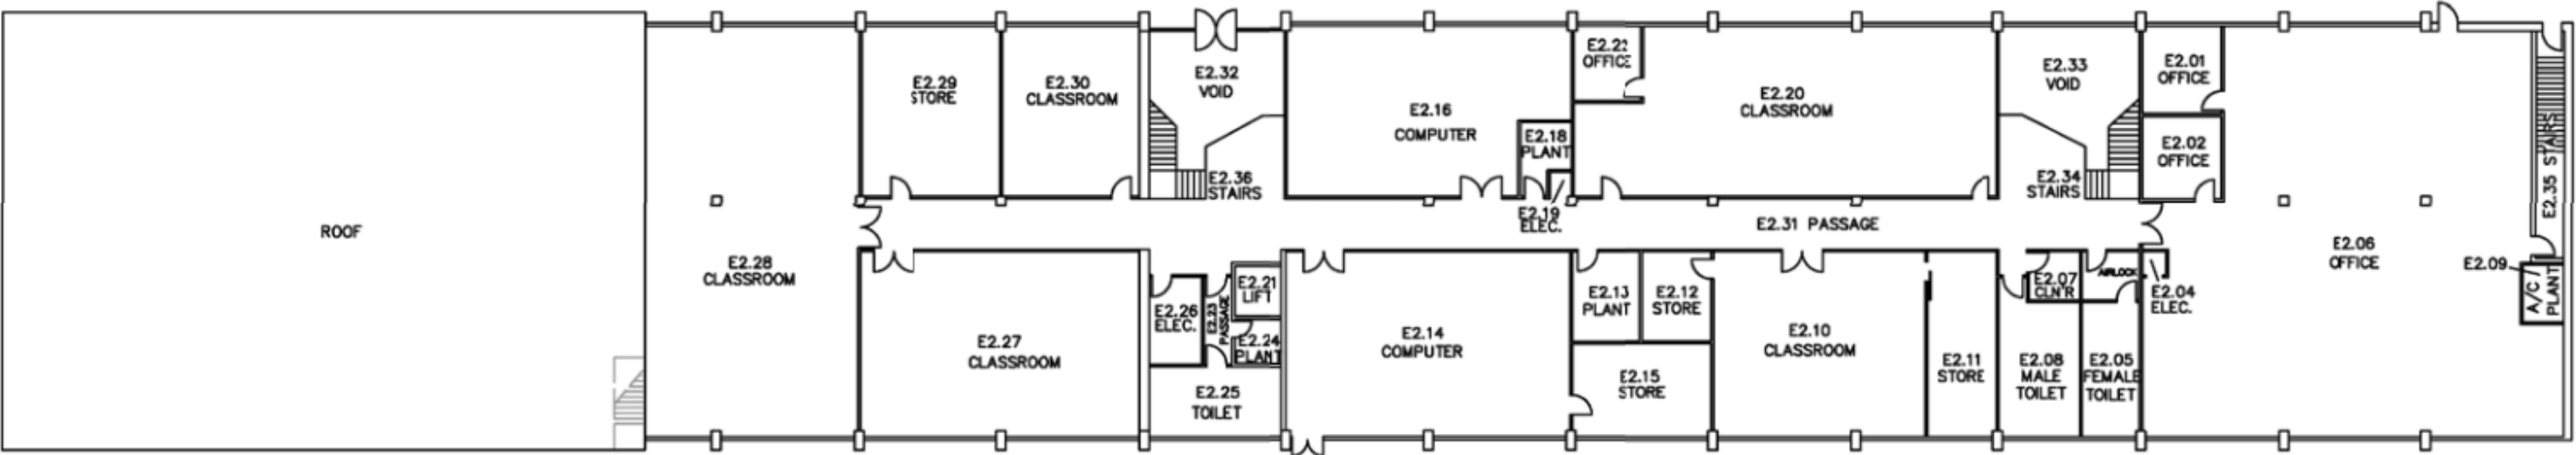
AREA: Block E - Level One

ASSUMED ASBESTOS SOFFITS  
SOUTHERN AND NORTHERN ELEVATION
