# COMPLIANCE ASBESTOS RE-INSPECTION AND RISK ASSESSMENT

NOVEMBER 2021

J033444

ROCKHAMPTON CITY CAMPUS\_Block H - Canning Street  
Canning Street  
ROCKHAMPTON QLD  
4700

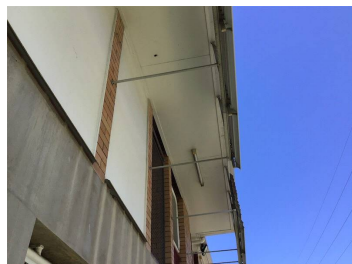
Location		Block H - 1st Floor - External - Soffit - Fibre cement sheet - All elevations

1	Block H -1st Floor -External, All elevations												
	Soffit -Fibre cement sheet	Asbestos	Visual	Assumed, Positive	80m <sup>2</sup>	No	Good Condition	Non-friable	Very Low	Low	P4	Conduct Further Investigations/Sampling Prior to Disturbance

Hazard Type		Asbestos	Material Assessment		Disturbance Assessment		
Friability		Non-friable	Product Type	1	Occupancy		0
Sample No.		Visual	Extent of damage	0	Disturbance		1
Result		Assumed Positive Unknown or Crocidolite	Surface Treatment	1	Exposure		0
			Asbestos Type	3	Maintenance		0
Item Number		1	Material Score	5	Disturbance Score		1
			Priority Score	6	Very Low		
No Additional Photographic Evidence Available

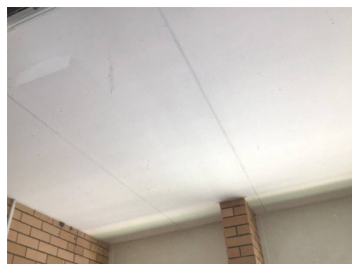
Location		Block H - 1st Floor - External - Awning - Fibre cement sheet - Northern Verandah

Hazard Type		Asbestos	Material Assessment		Disturbance Assessment		
Friability		Non-friable	Product Type	1	Occupancy		0
Sample No.		As 3-935 {AO000130}	Extent of damage	0	Disturbance		1
Result		Strongly Assumed Positive Chrysotile	Surface Treatment	1	Exposure		0
			Asbestos Type	1	Maintenance		0
Item Number		4	Material Score	3	Disturbance Score		1
			Priority Score	4	Very Low		
No Additional Photographic Evidence Available

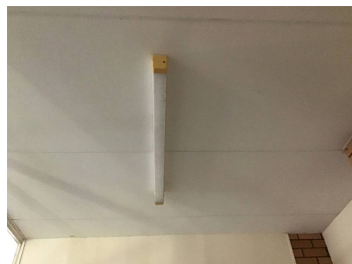
Location		Block H - 1st Floor - Store - Ceiling - Fibre cement sheet - Throughout

3	Block H -1st Floor -Store, H2.05, Throughout												
	Ceiling -Fibre cement sheet	Asbestos	As 3-935 {AO000130}	Strongly Assumed, Positive	-	No	-	-	-	-	-	No further action required	Removed

Hazard Type		Asbestos	Material Assessment		Disturbance Assessment			
Friability		Non-friable	Product Type	1	Occupancy		0	
Sample No.		3-935 (AO000130)	Extent of damage	0	Disturbance		1	
Result		Positive Chrysotile		Surface Treatment	1		Exposure	0
				Asbestos Type	1		Maintenance	0
Item Number		2		Material Score	3		Disturbance Score	1
				Priority Score	4		Very Low	
No Additional Photographic Evidence Available
